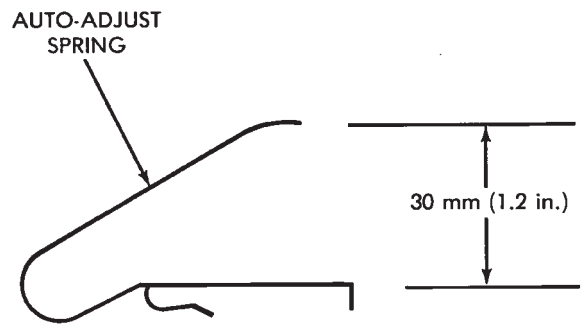
Fig. 1 Clutch Cable Auto-Adjust Spring

The cause of this noise in most cases is the clutch cable auto-adjust spring being below design load specifications. To correct the problem, bend the auto-adjust spring to bring it back to specifications or replace the spring (Fig. 1).

The auto-adjust spring is located on the back of the clutch pedal.
