HVAC Removal with Pictures

For the last month, I have not been able to control air flow between the floor and defrost. Therefore, I thought it was time to replace the defrost door (TSB 24-004-03). I decided to take a few pictures of the removal process. I have also included brief instructions. This was the first HVAC unit I have removed, it took about 8 hours to remove, repair, and replace using hand tools.

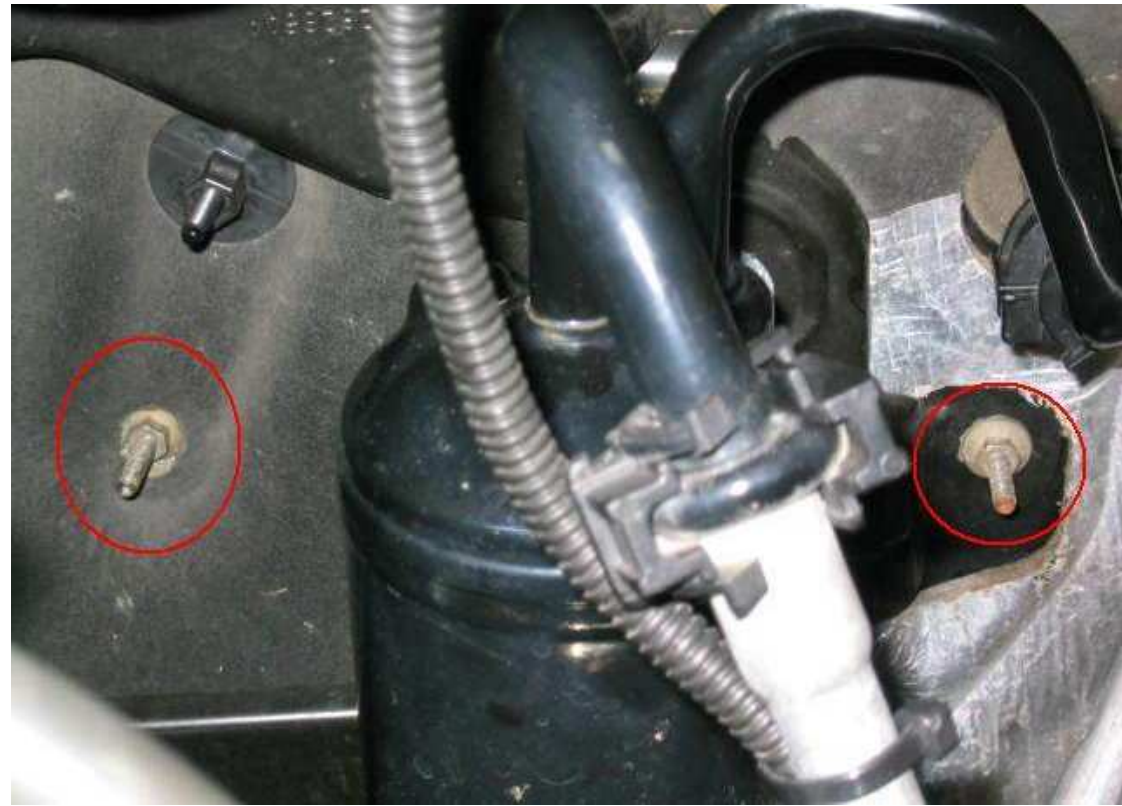
1. Evacuate AC system.
2. Drain two or three gallons of antifreeze from the radiator.
3. Disconnect battery ground cables.
4. Disconnect heater hoses from heater core. Tape over the heater core tubes to prevent leaks during HVAC removal.
5. Loosen accumulator mounting bolts and disconnect evaporator lines using disconnect tool. Tape over tubes and line openings to prevent contamination and leaks during removal.
6. Remove nuts from the two HVAC studs.

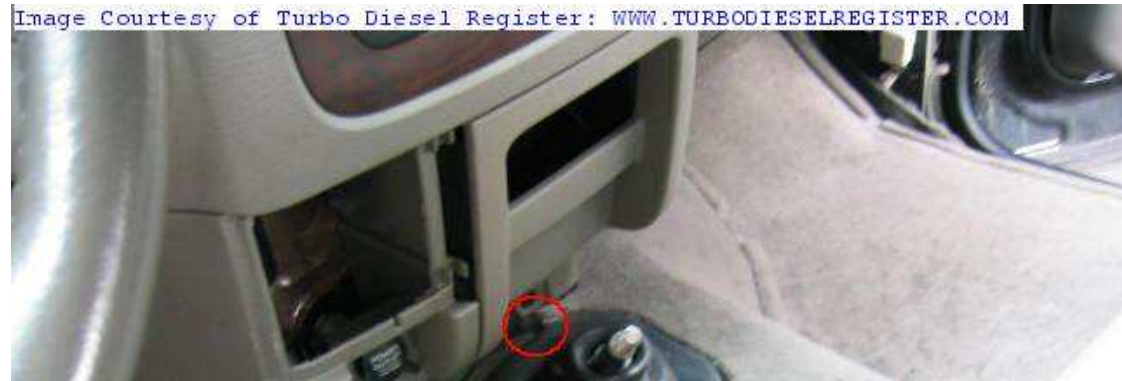
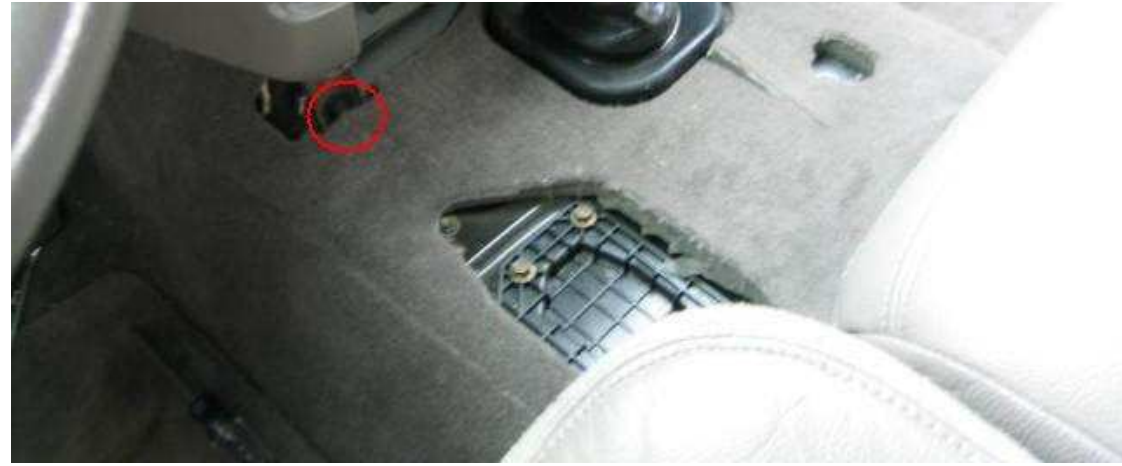
7. Remove center console, I choose to remove shift lever also. If you do not have a center console then a small trim panel will need to be removed.
8. Remove center IP bolts.

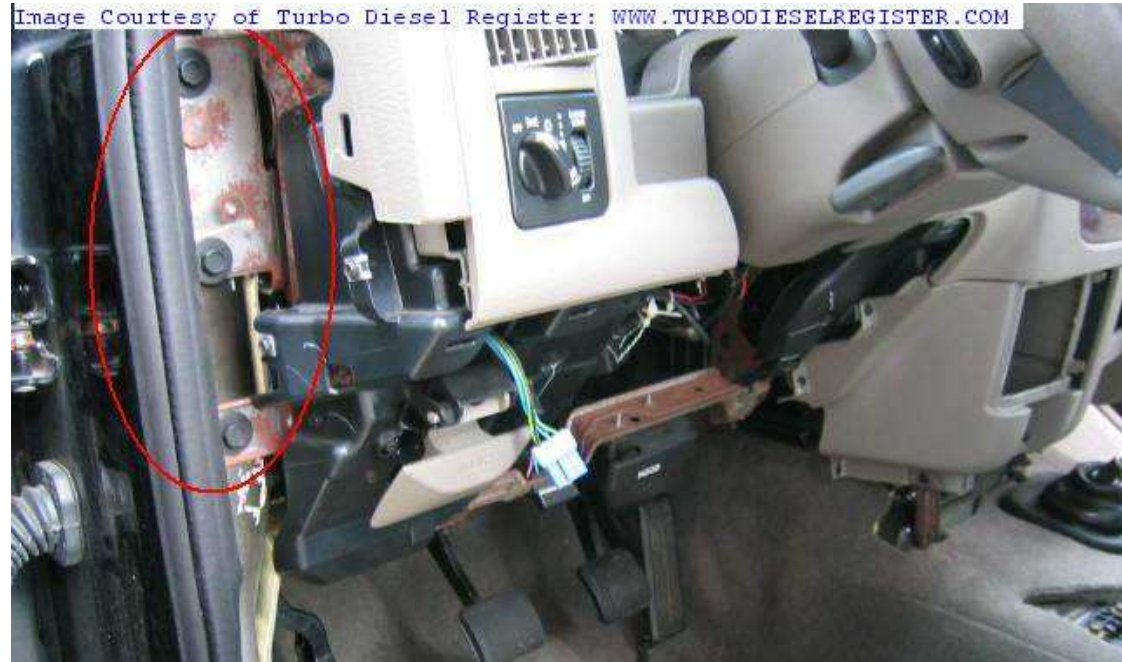
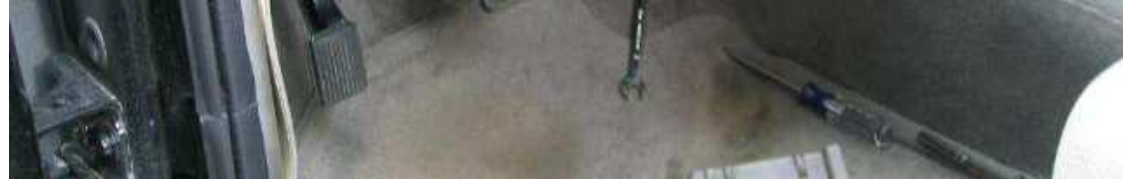
9. Remove left and right a-pillar trim, side covers, and cowl trip panels.
10. On left side, remove the knee blocker trim panel and trim panel around the park brake release handle.
11. Disconnect park brake release rod.
12. Remove the three left IP attachment bolts.

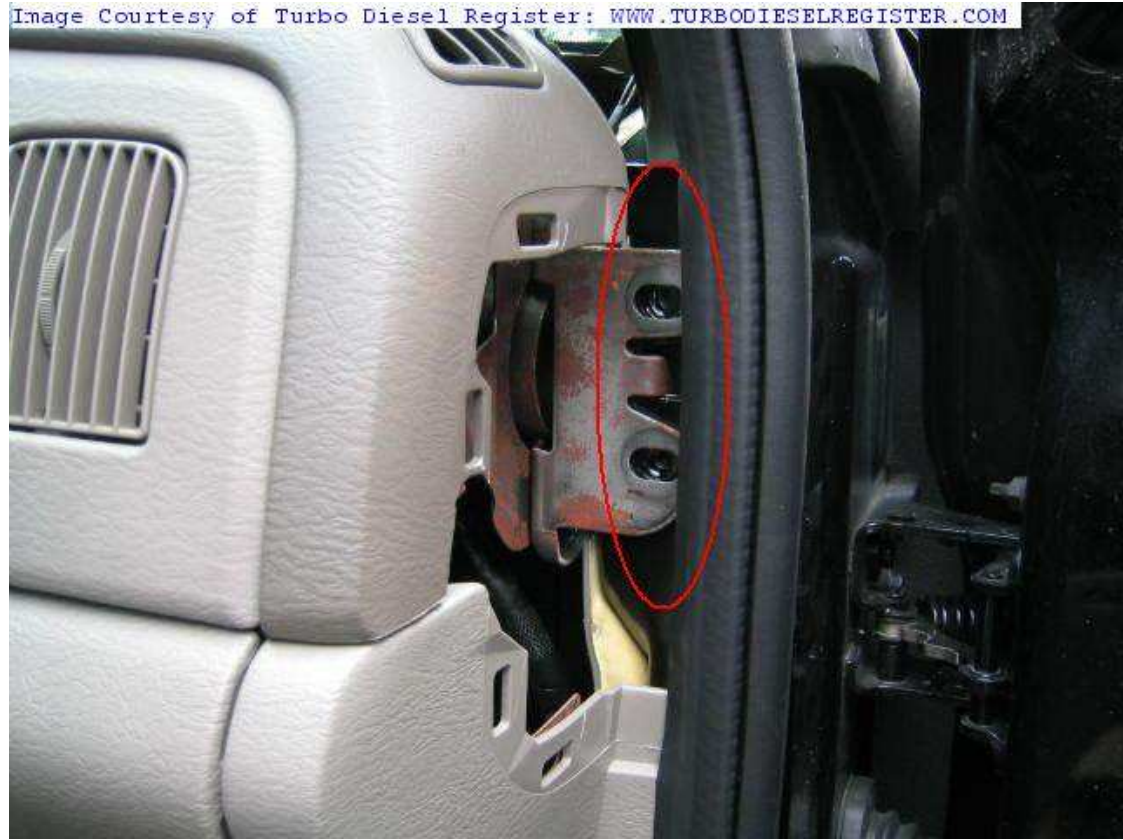
13. Remove the three right IP attachment bolts.

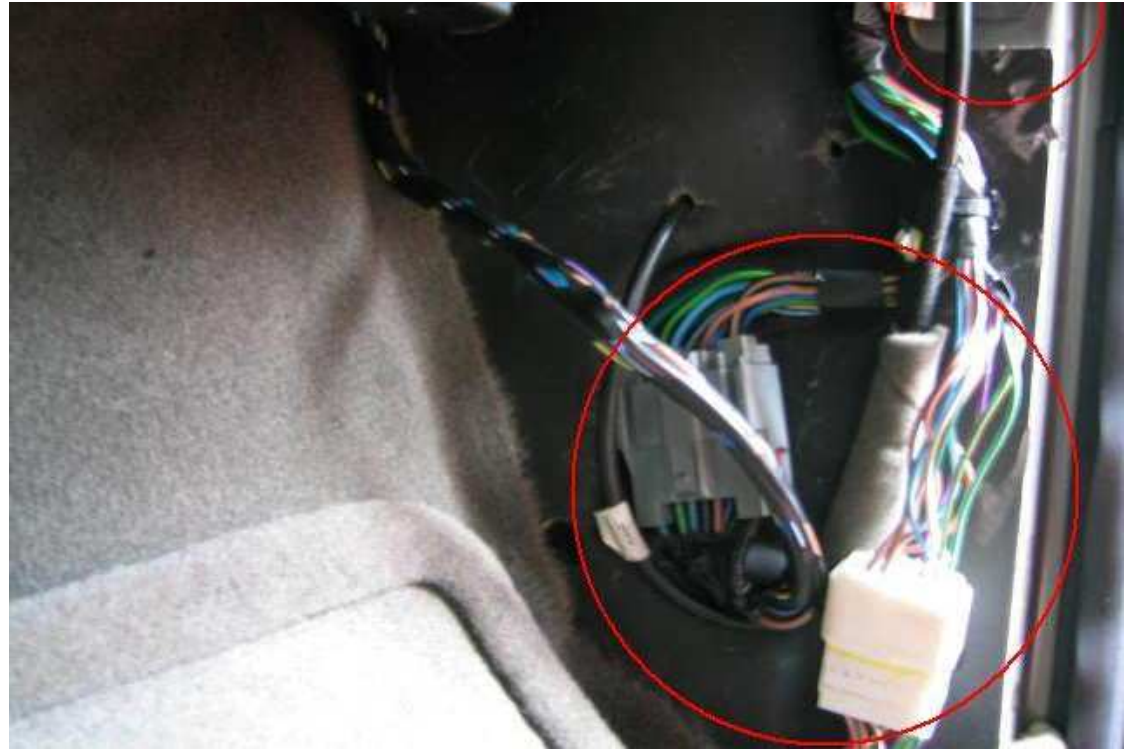
14. Disconnect electrical and radio antenna wire connectors behind right cowl trim panel.

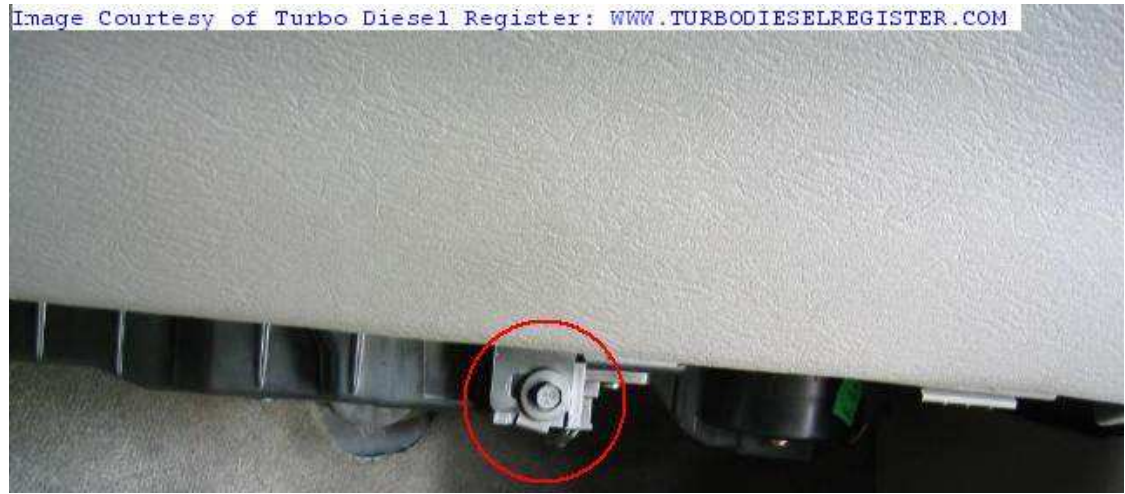
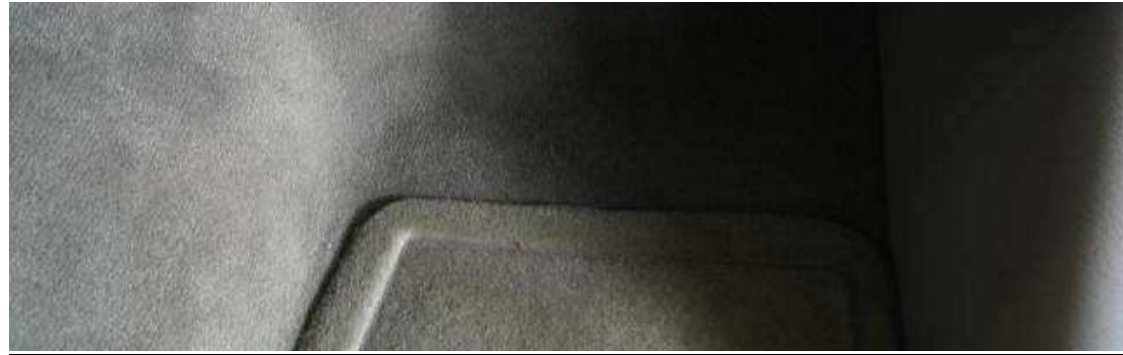
15. Remove bolt attaching metal strap to HVAC housing (under glove box)

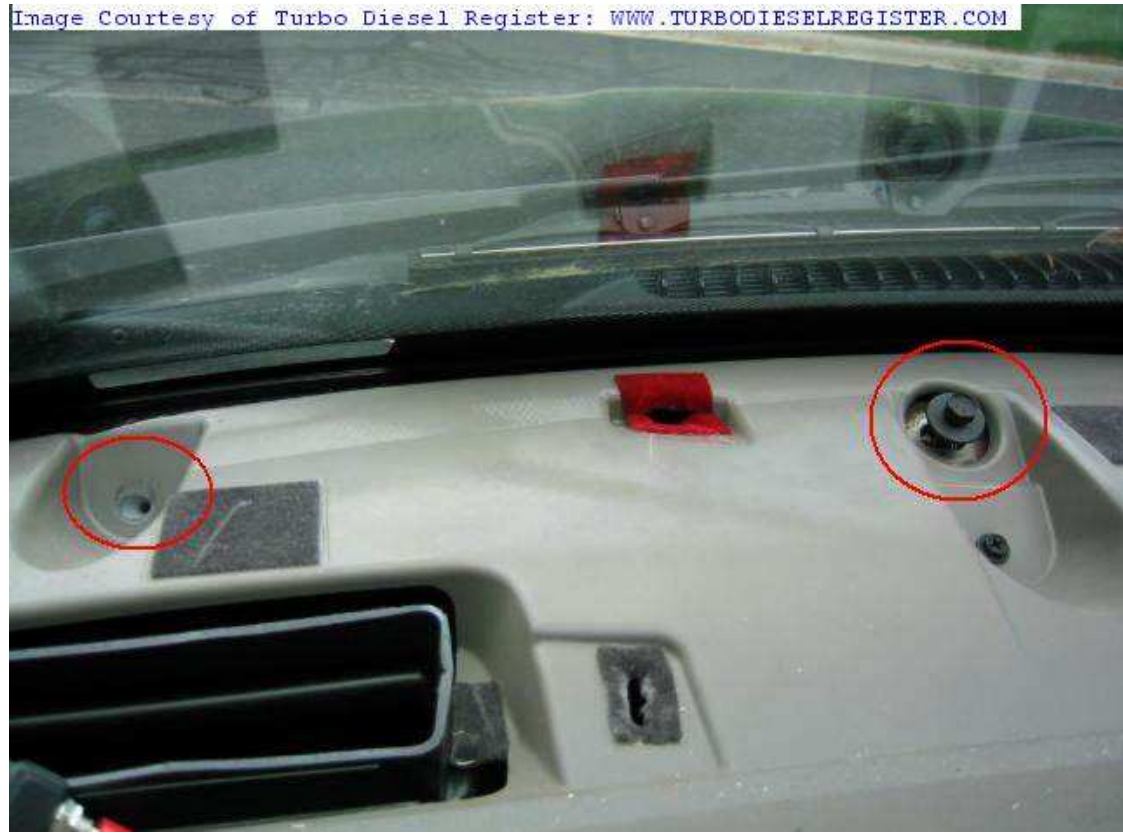
16. Remove top IP cover. First pry up on the back of the panel to disconnect rear clips. Then pull panel back to unsnap front clips.

17. Remove 4 small screws and 2 bolts attaching the upper IP to body.

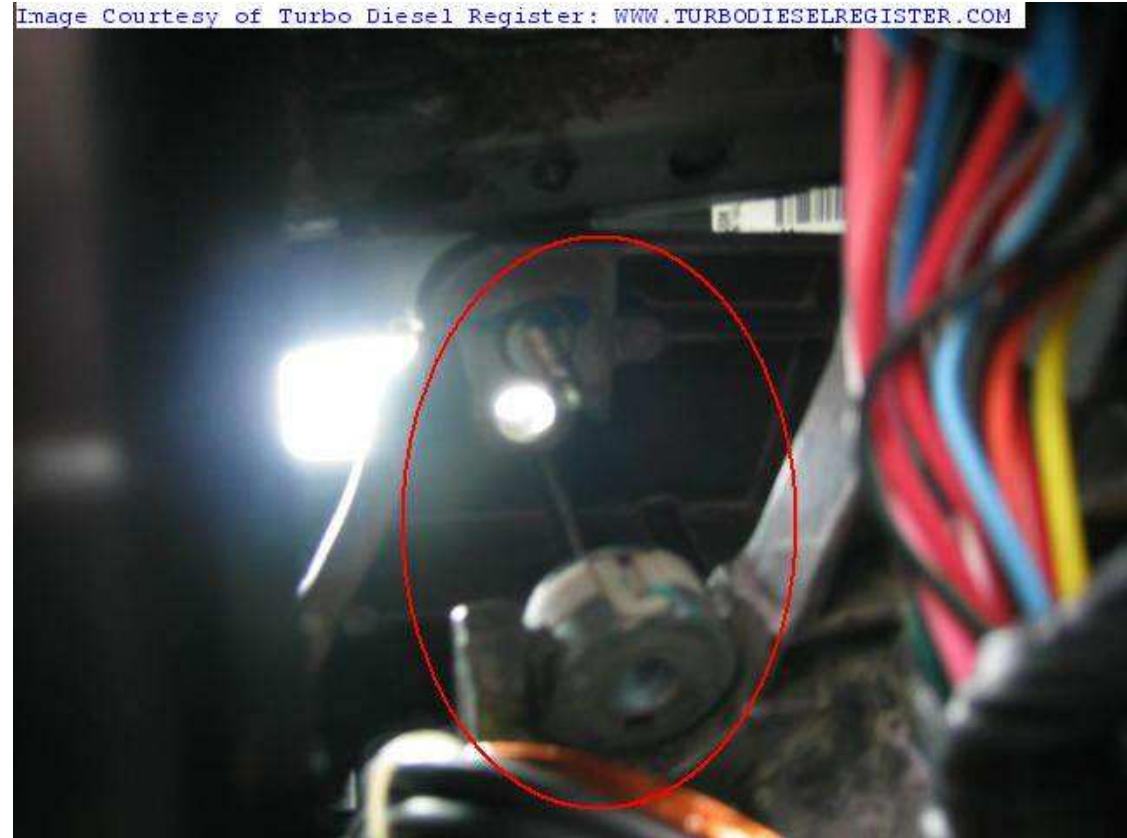
18. Remove the bracket holding the diagnostics port and hood release lever.
19. Remove 4 nuts attaching steering column. Lower steering column until the steering wheel rests on the driver's seat. Be sure to watch the brake switch as it could be damaged.

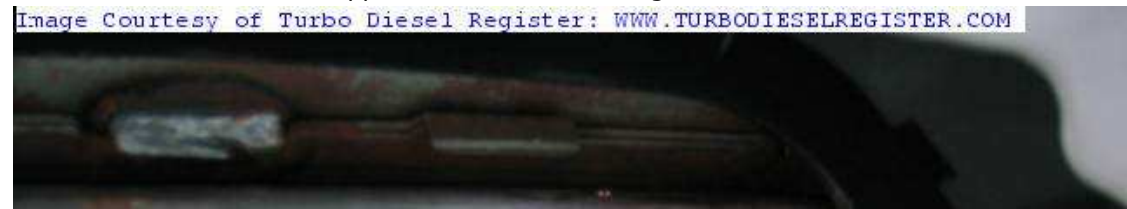
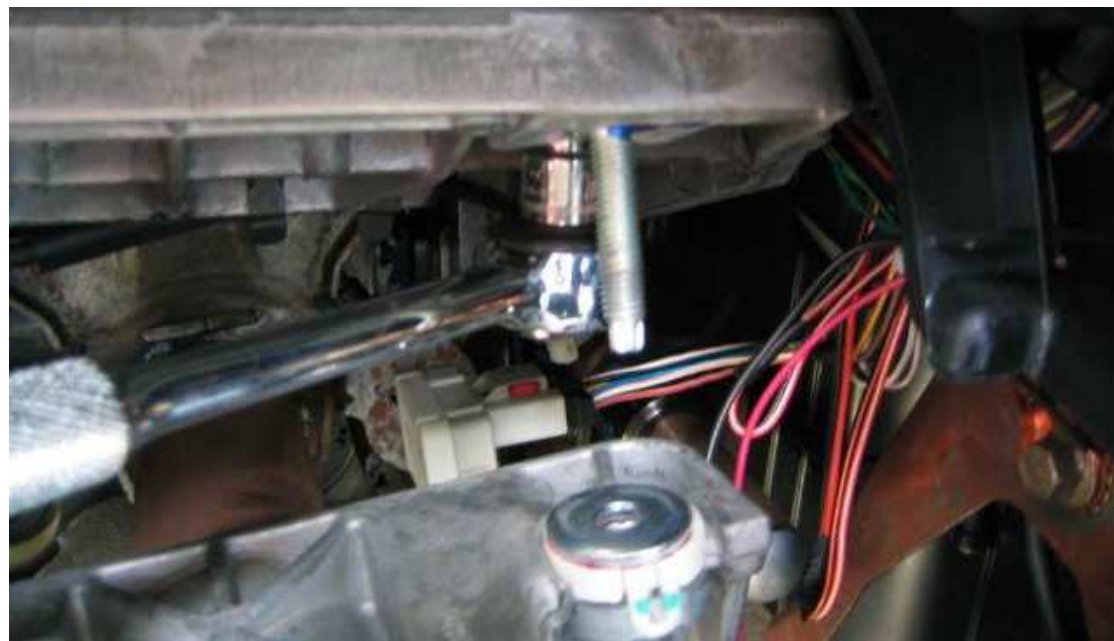
20. Remove both column support bolts above steering column.

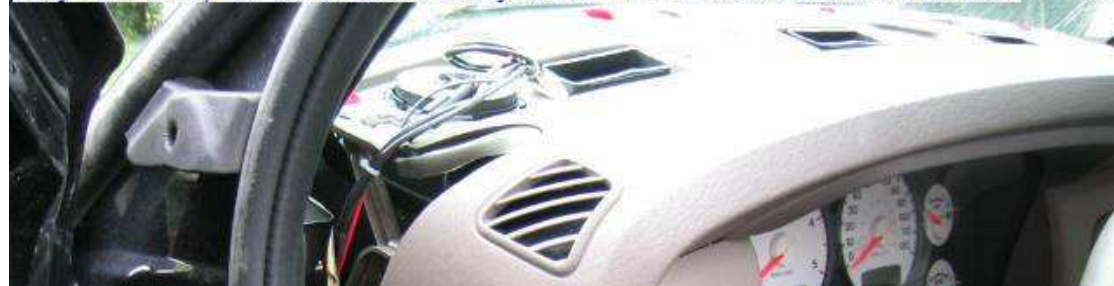
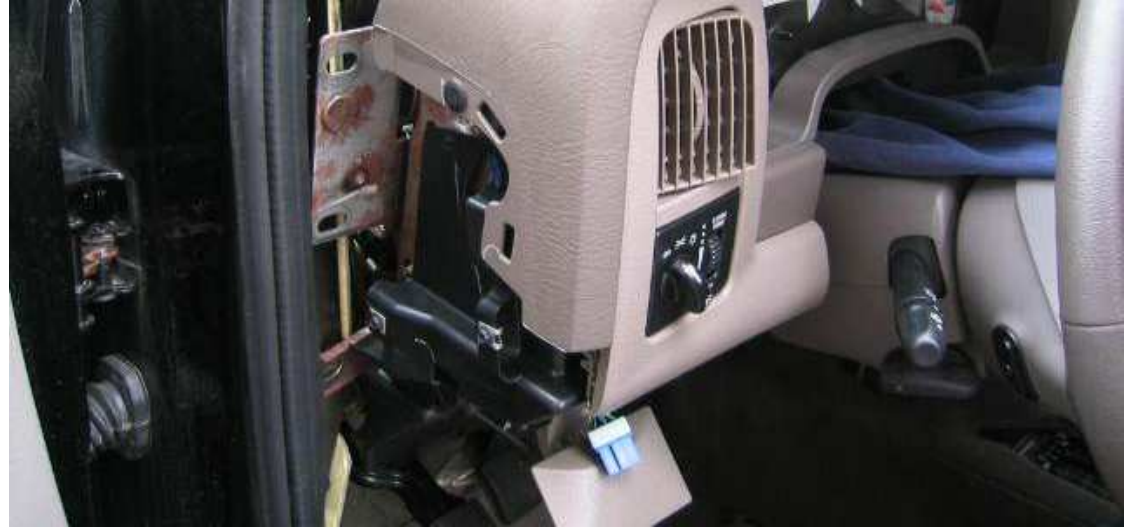
21. Pull IP back.

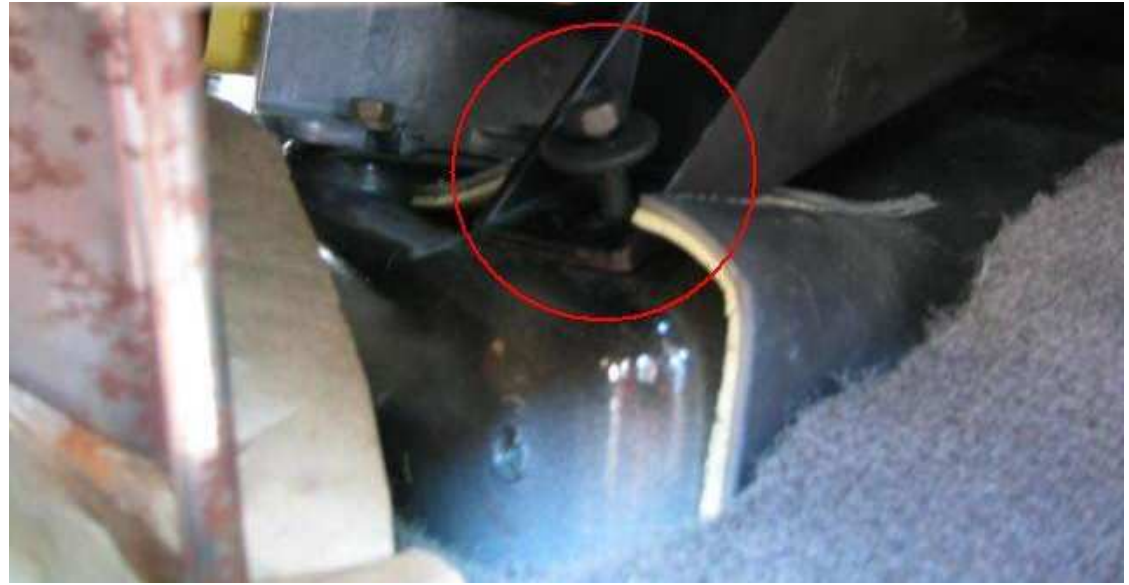
22. Remove lower HVAC housing mounting bolt.

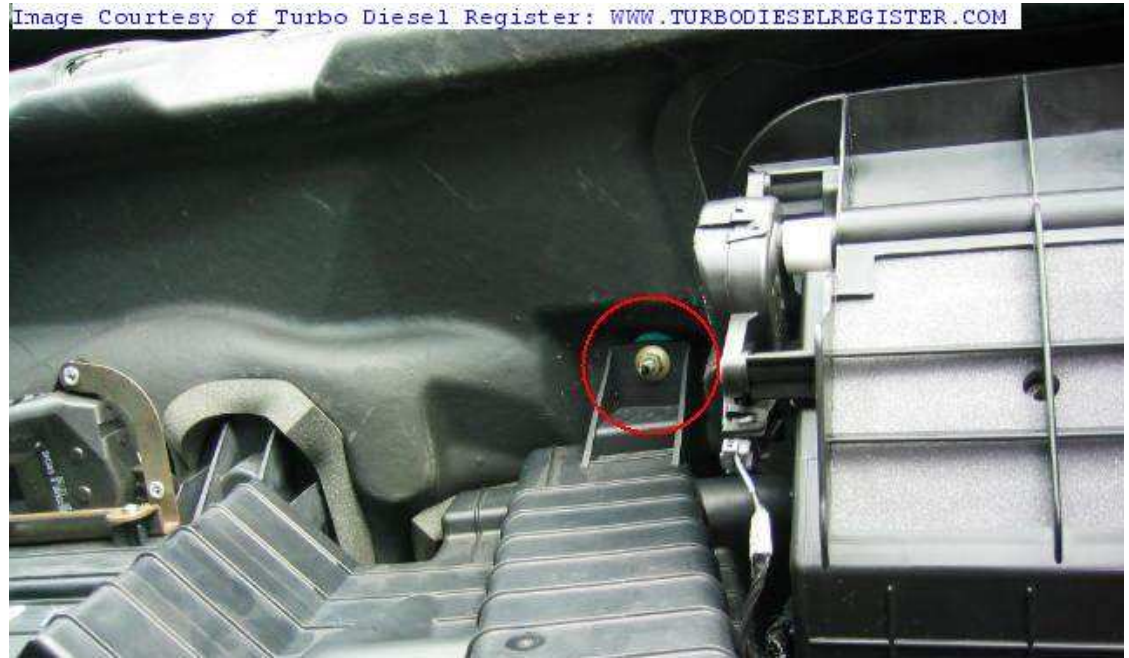
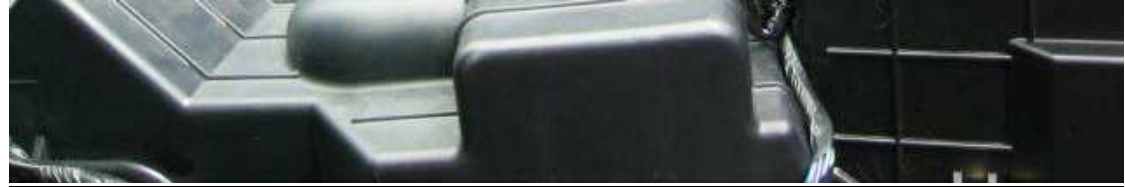
23. Remove two nuts on upper HVAC mounting studs.

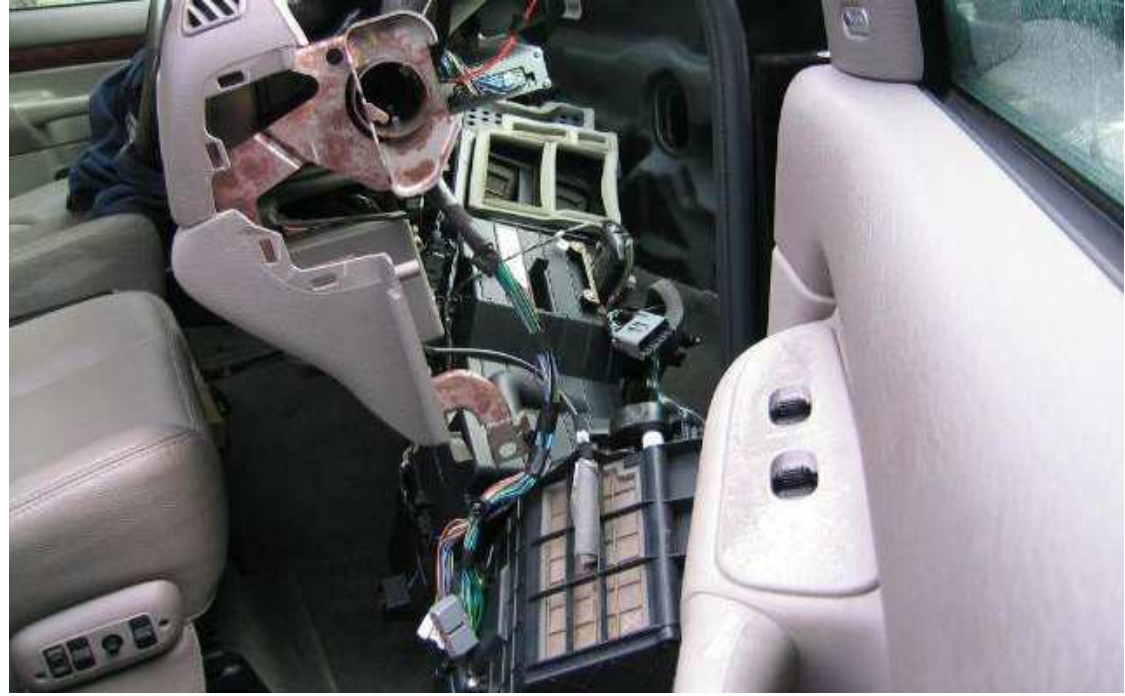
24. Remove the HVAC unit.

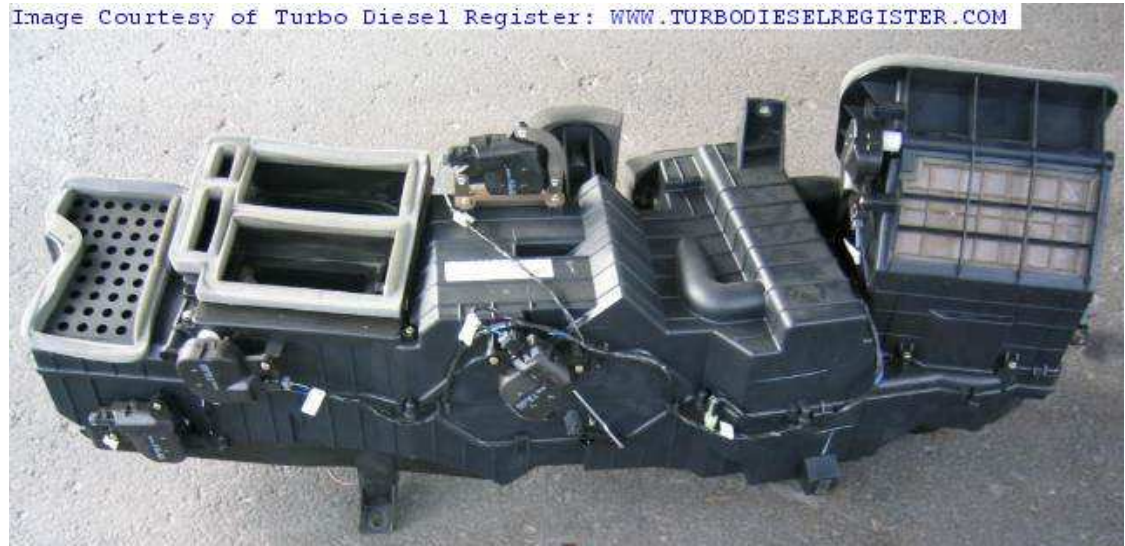
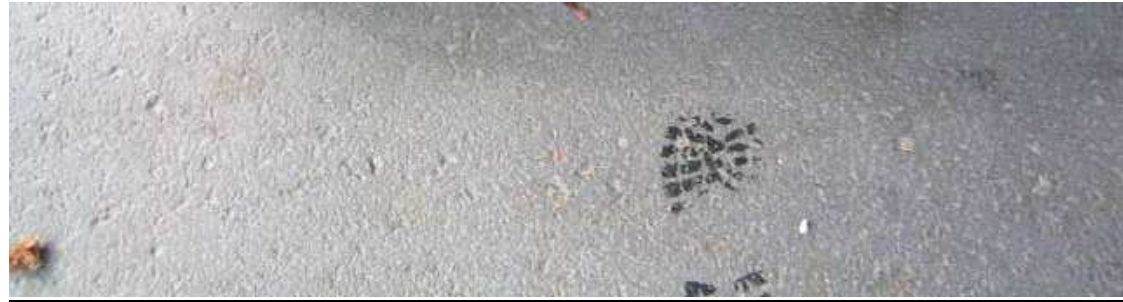
25. Disassembly HVAC unit and replace any broken components.

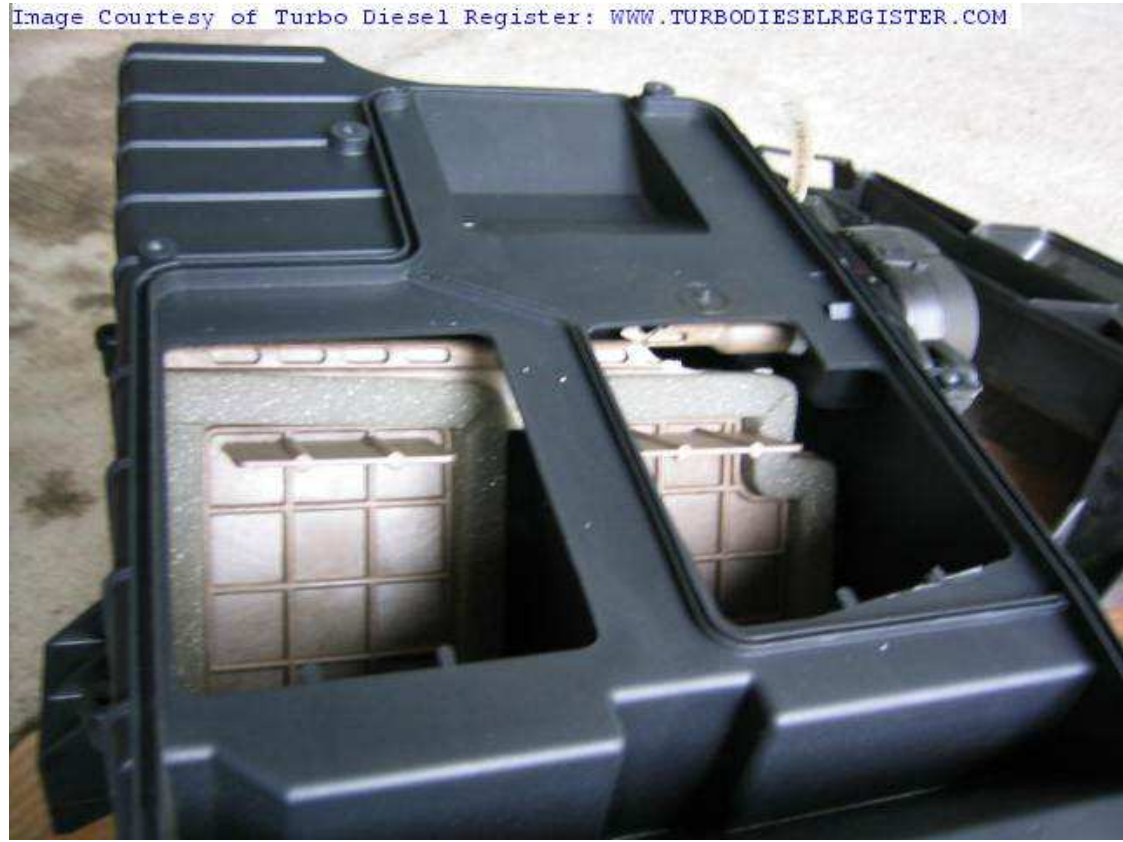
During disassembly I found just what I was looking for, a broken defrost door.

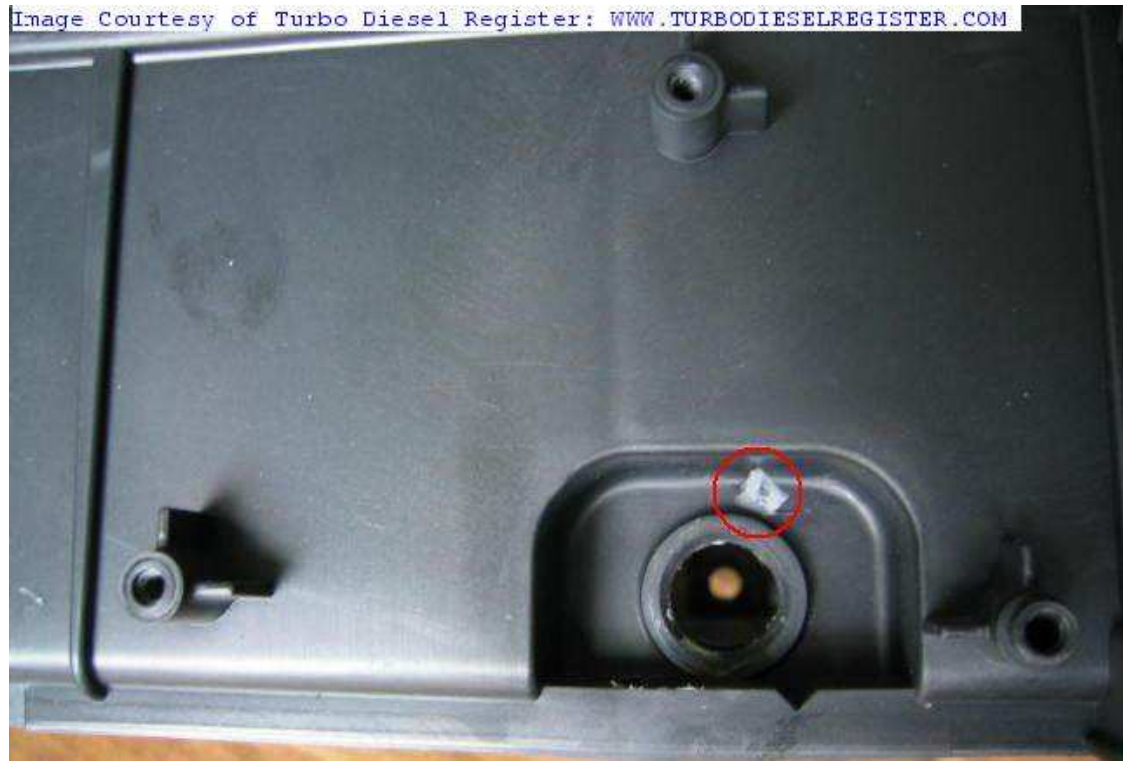
The door broke after the actuator stop broke on the lower HVAC housing.

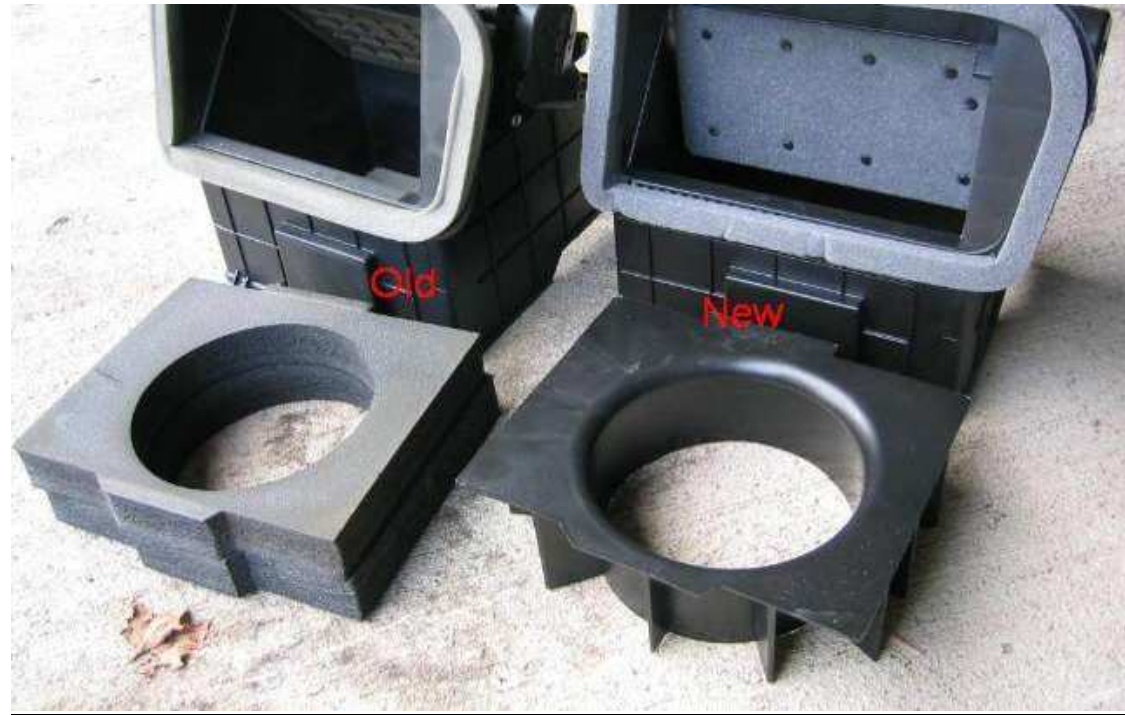
I also choose to replace the recirculation door even though it was not yet broken, probably just a matter of time. The recirculation door is now serviced as an assembly. You get the housing, door, actuator adapter, and actuator.

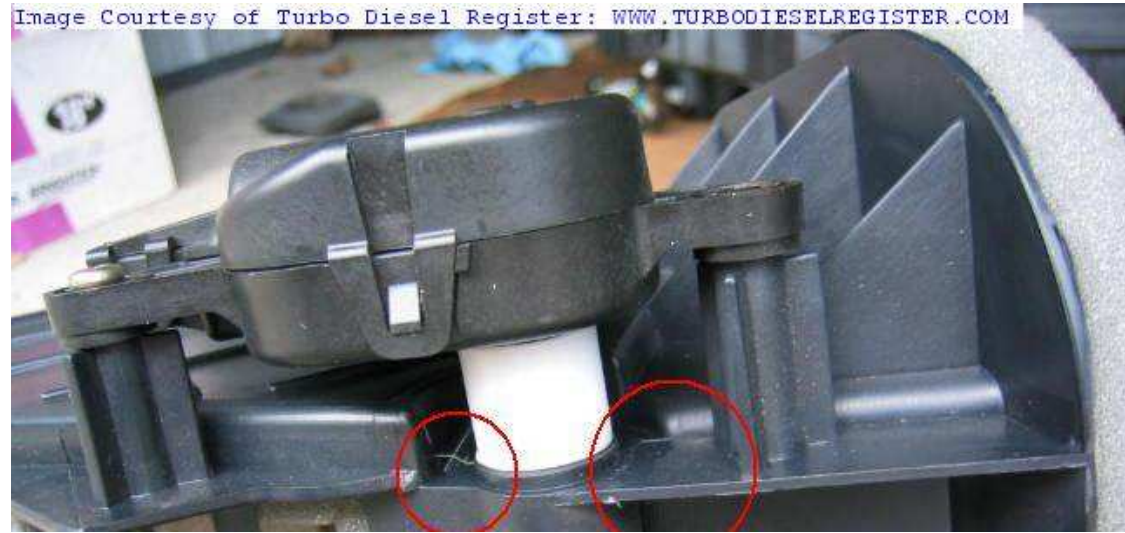
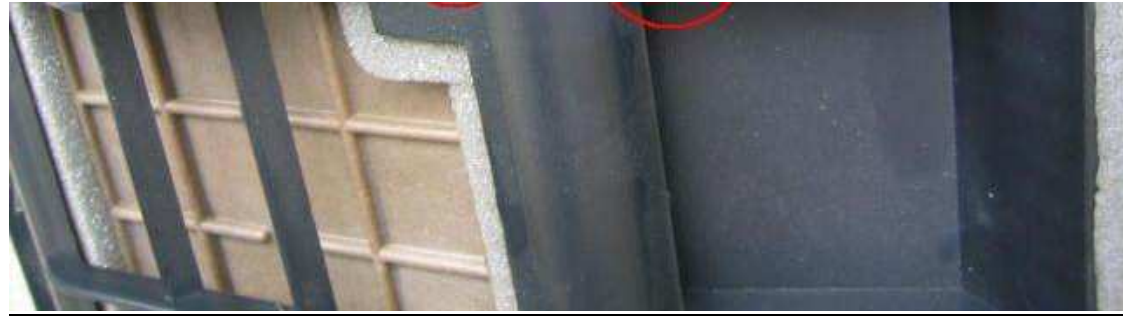
No motor actuator stops on the old recirculation housing.

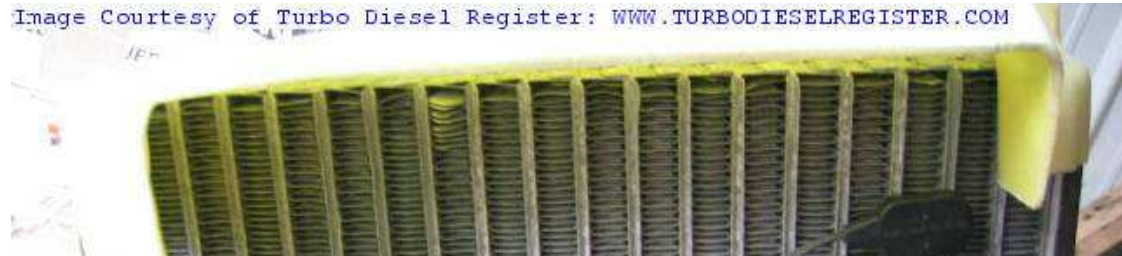
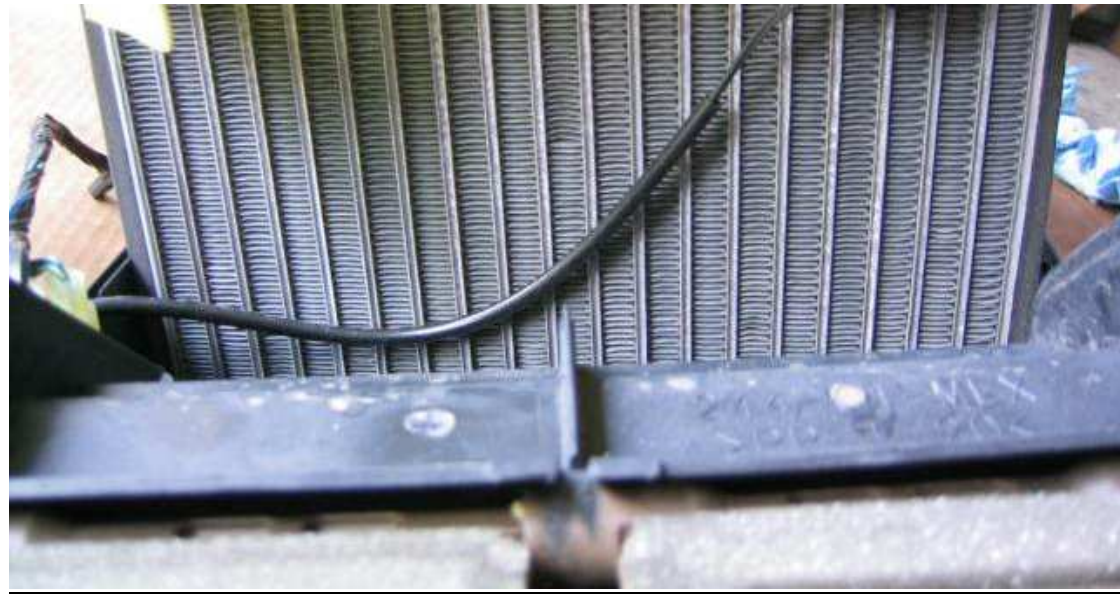
Lastly, here is a picture of the evaporator with the temp sensor in the factory location.
