After having my HVAC doors break for the second time, I have decided to once-and-for-all fix the HVAC by replacing all four doors (non-dual climate control) with the steel Heater Treater replacement doors. Right now, I only have air coming out of the panel vents with no floor heat and no defrost capability.

Heater Treater four-door kit with new Recirculation housing:

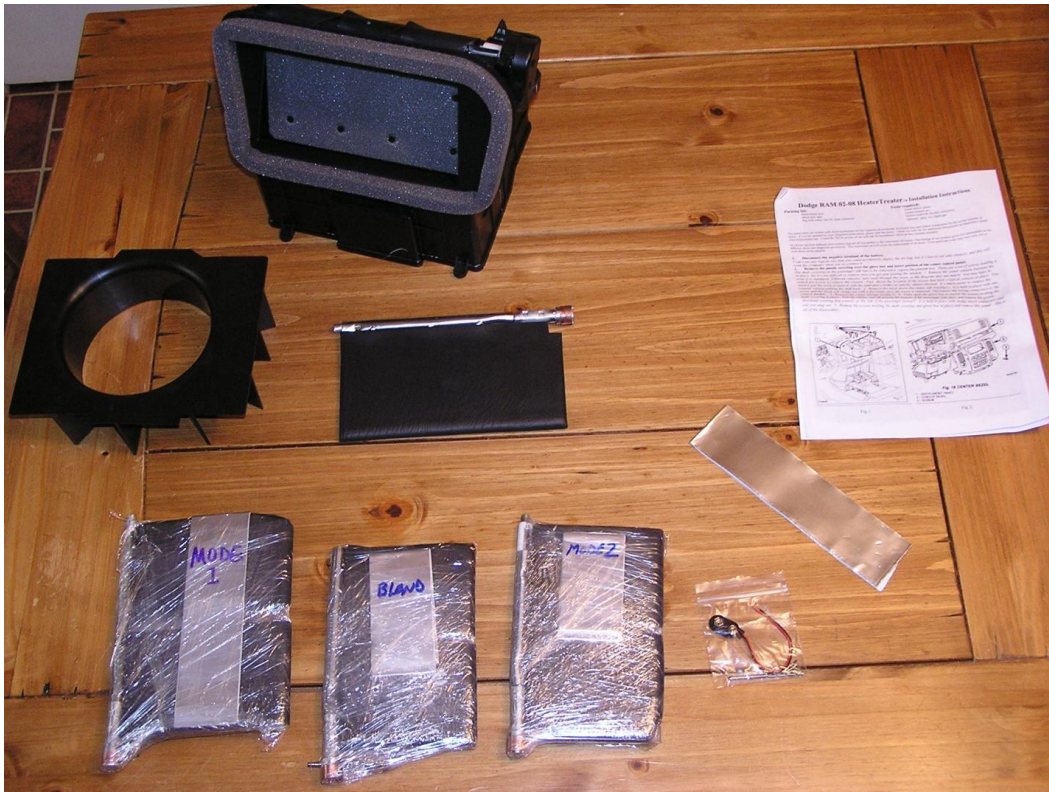
Heater Treater replacement doors, \$229 delivered. Ordered Friday, USPS delivered Tuesday. In the kit is 9v set of wire leads that enables you to check each actuator/door function without the need to connect the HVAC control harness. This is a nice touch. You see the doors labeled Blend, Mode 1 and Mode 2. The Mode 1 is actually the Defrost door and the Mode 2 is actually the Mode door and controls the floor vents. However, the Heater Treater folks really put a premium on not pulling the dash, and have designed their instructions (which, by the way, are very thorough, in addition to their installation videos on their website) for the installer to cut into the HVAC box and cut some of the metal frame behind the ash tray/cup holder area in the dash for the R&R of a couple of the HVAC doors. That may be a good alternative for some folks, but I am one of those ISTJ types (Myers-Briggs personality indicator), and cutting into the box just doesn't "cut it" for me. IMHO, the only way to do this right, is complete disassemble/reassemble.

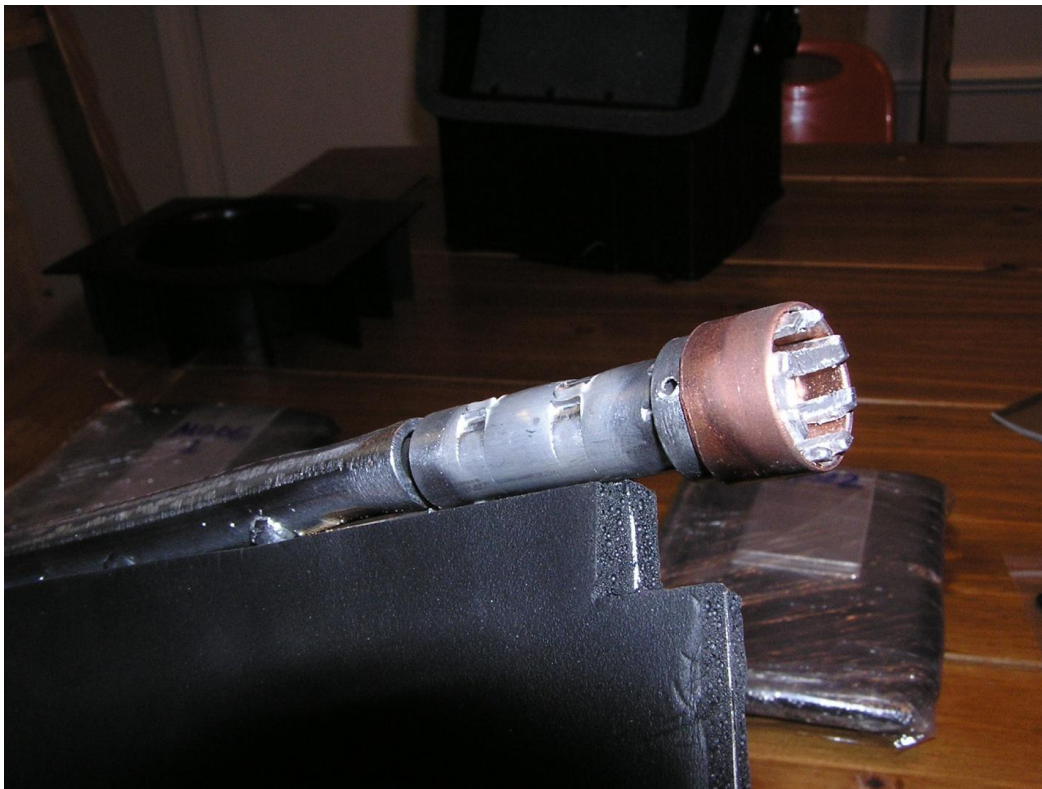
I replaced the recirculation door with the Heater Treater recirculation door. The interesting issue is that the Heater Treater coupler doesn't have the stud that engages the coupler stops on the housing. It isn't really needed as the recirculation housing itself provides the stops for the doors, which also makes the stops on the redesigned housing a moot point as well. Now I am wondering why the redesign of the housing? I am leaving the recirculation housing off the HVAC box until I disassemble it, replace the doors, and reassemble.

Heater Treater Recirculation Coupler:

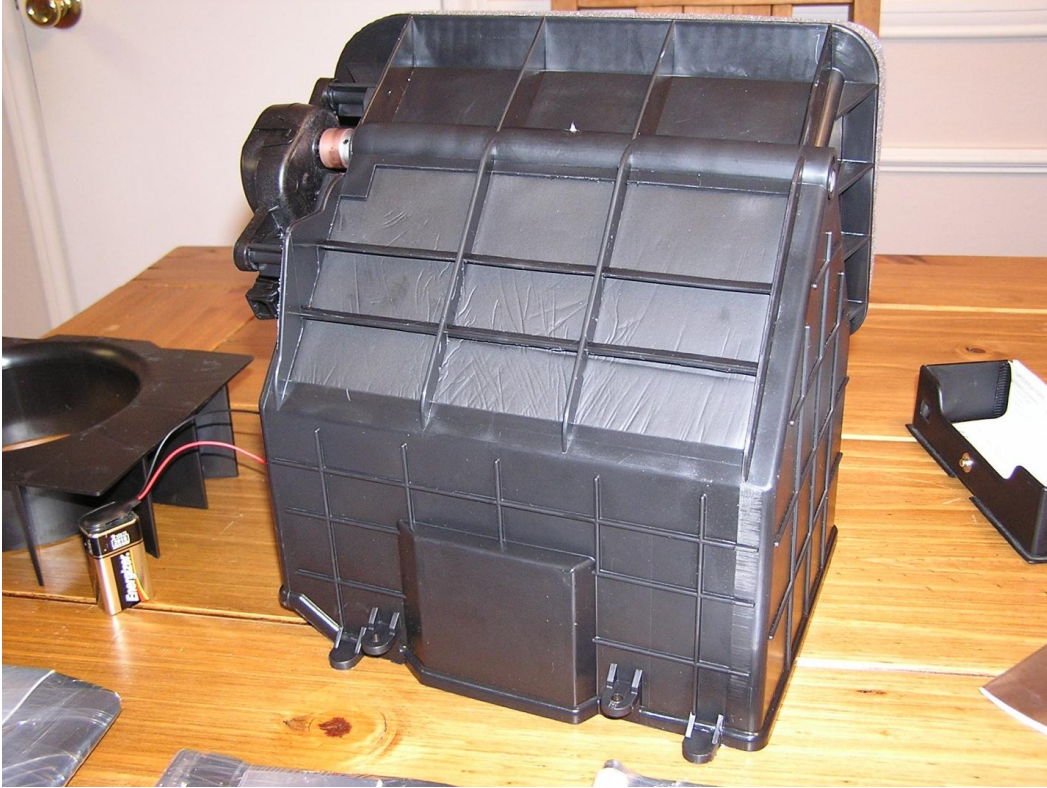
Updated recirculation housing with Heater Treater door installed:

Due to my recirculation door not breaking at the time, they did not replace the recirculation door or the recirculation housing that has been updated with coupler stops. I am not even sure if the new recirculation housing was available at that time. But again, this is a once-and-for-all fix, so I bought the updated recirculation housing from the local dealer for just shy of \$49, part number 68004226AB. By the way, one lady behind the parts counter knew the part number by-heart. I mentioned, "I guess you get pretty familiar with parts you replace a lot, don't you?" She replied emphatically, "Yes." It's also interesting to note that the housing comes complete with door, door coupler, and actuator...and used to cost less than \$20 when it was released several years back. At less than \$50 now (\$55 retail), it's probably still a good deal versus buying all of the parts separately.

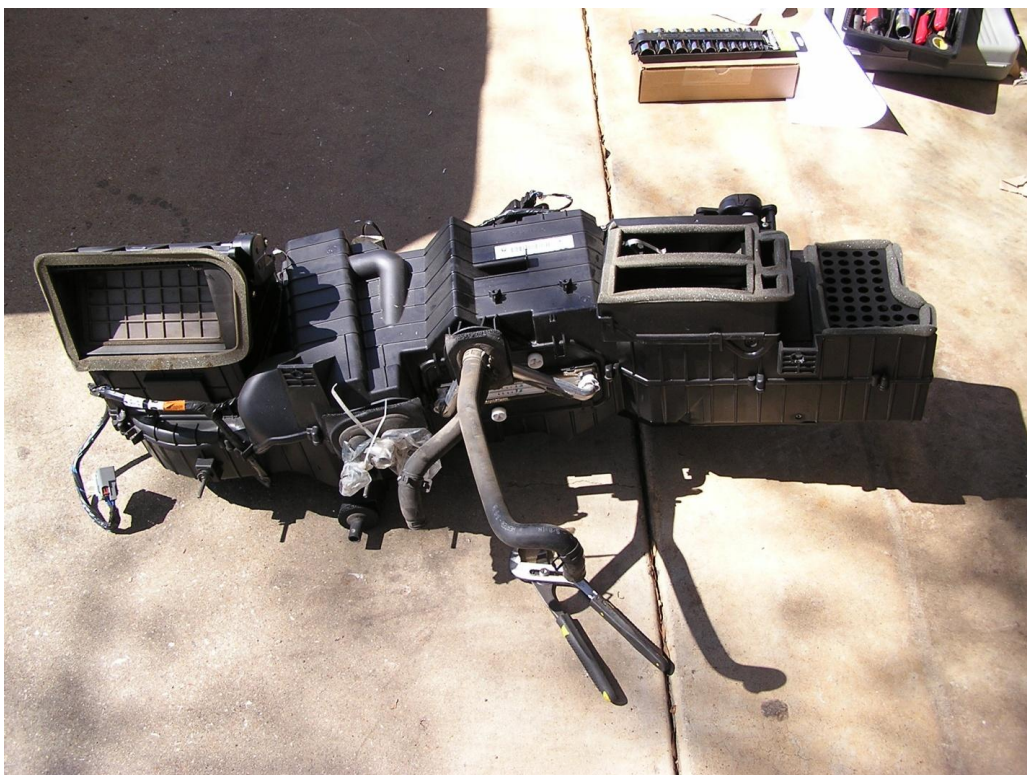
Disassemble HVAC box by removing the dozen or so screws from around the periphery of the box.

With each door, remove the actuator by removing the two Phillips-head screws and disengaging from the coupler. Take a set of needle nose pliers and pull the coupler straight out of the door axle. Once the coupler is removed, the door falls out. Reinstall in reverse with Heater Treater door and steel coupler, and actuator (don't worry about door position) into/onto the housing.

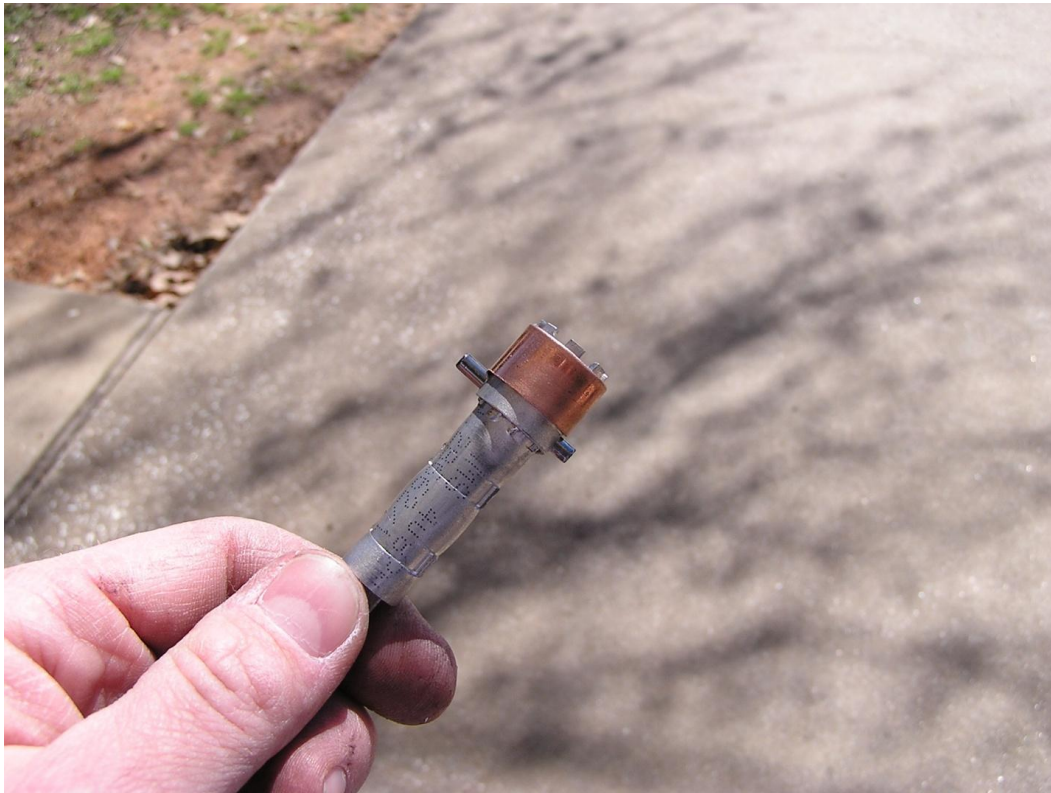
On one of the couplers, the drift pin that engages the door stops on the HVAC housing was too long and would not fit into the groove that leads to the stop. In some cases, the door stop is actually a groove cut into the housing plastic, versus a plastic projection that extends perpendicularly toward to door axle. In this case, I simply tapped the drift pin medially to shorten the pin on the door stop engaging side. Hope this makes sense. If you decide to do this project and run into this issue, you'll immediately know what I am talking about.

Shortened drift pin:

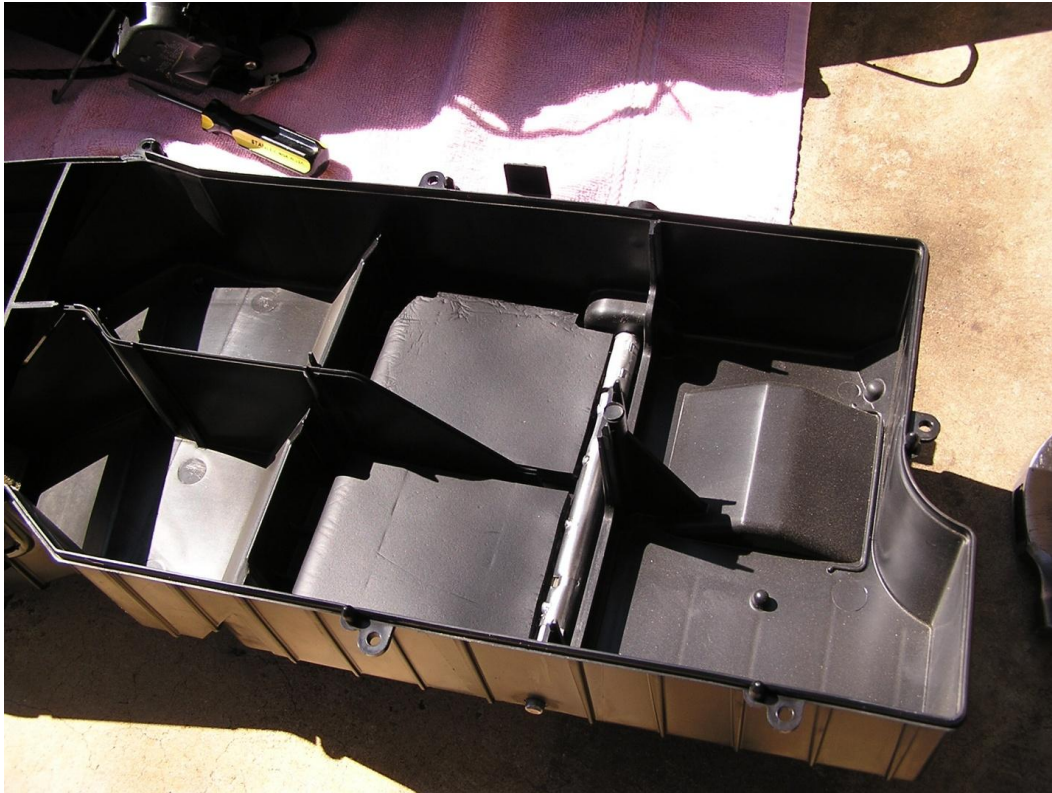
Mode 2 (as Heater Treater calls it), or Mode door/floor vent door replaced:

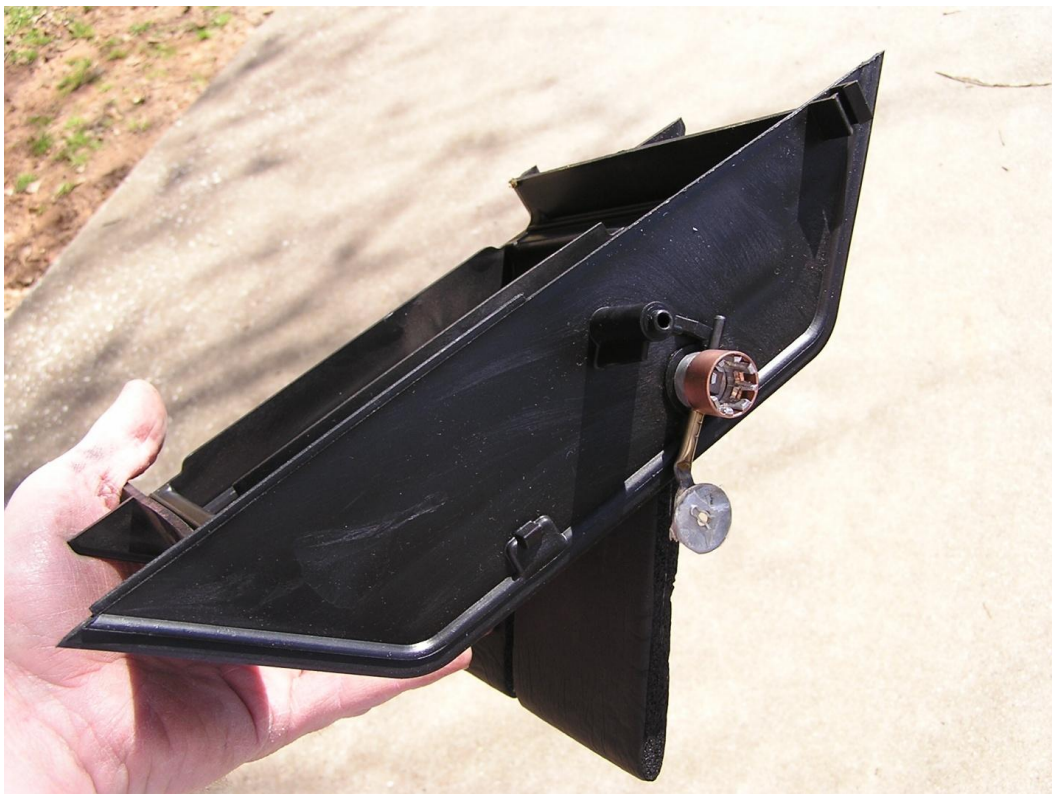
Blend door replaced. You'll notice the arm that connects to another door below the heater coil via a rod and are actuated together. This door is not replaced, but I cannot think of a single incident where that door has broken. It doesn't engage anything; it just rotates on its axle:

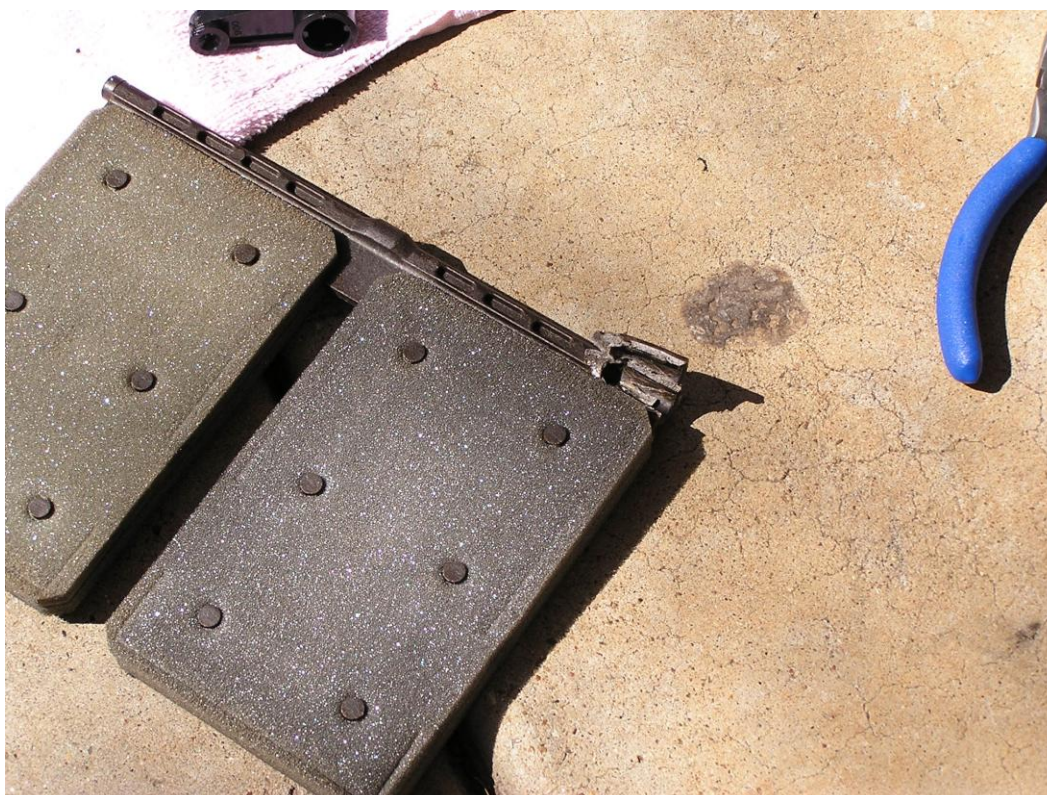
The culprit for my woes: Broken Defrost door, (or Mode 1 door as Heater Treater calls it). This is the second time it has broken...and the last.

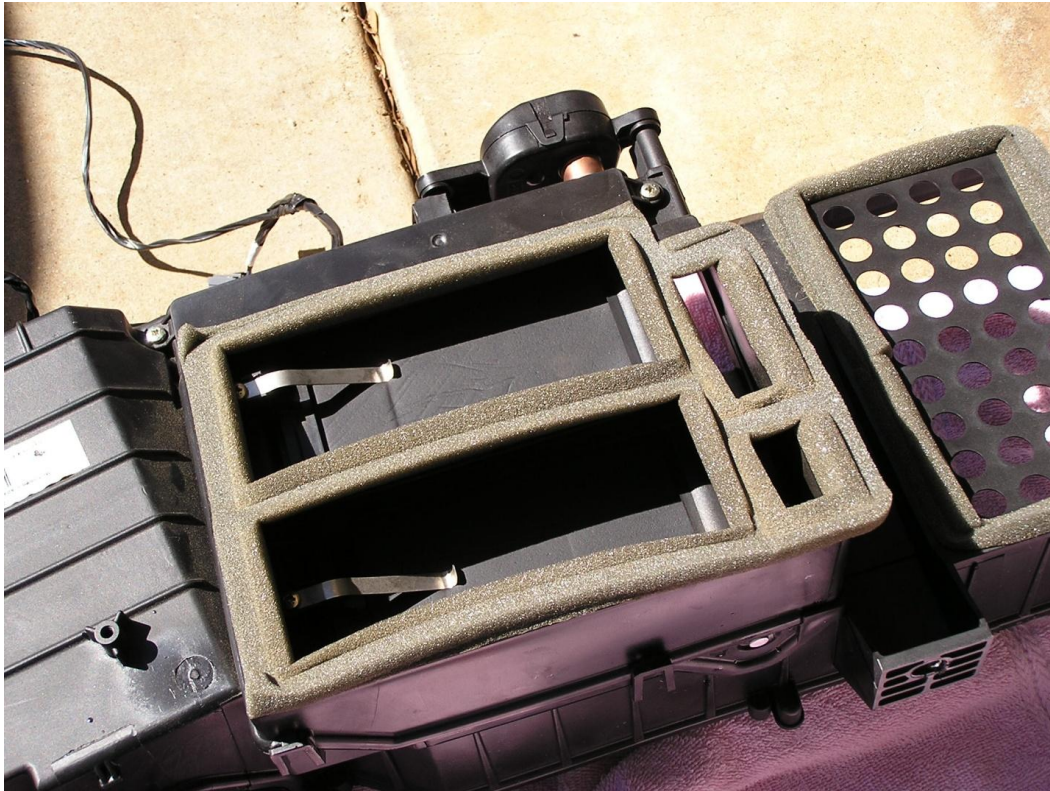
New defrost door installed:

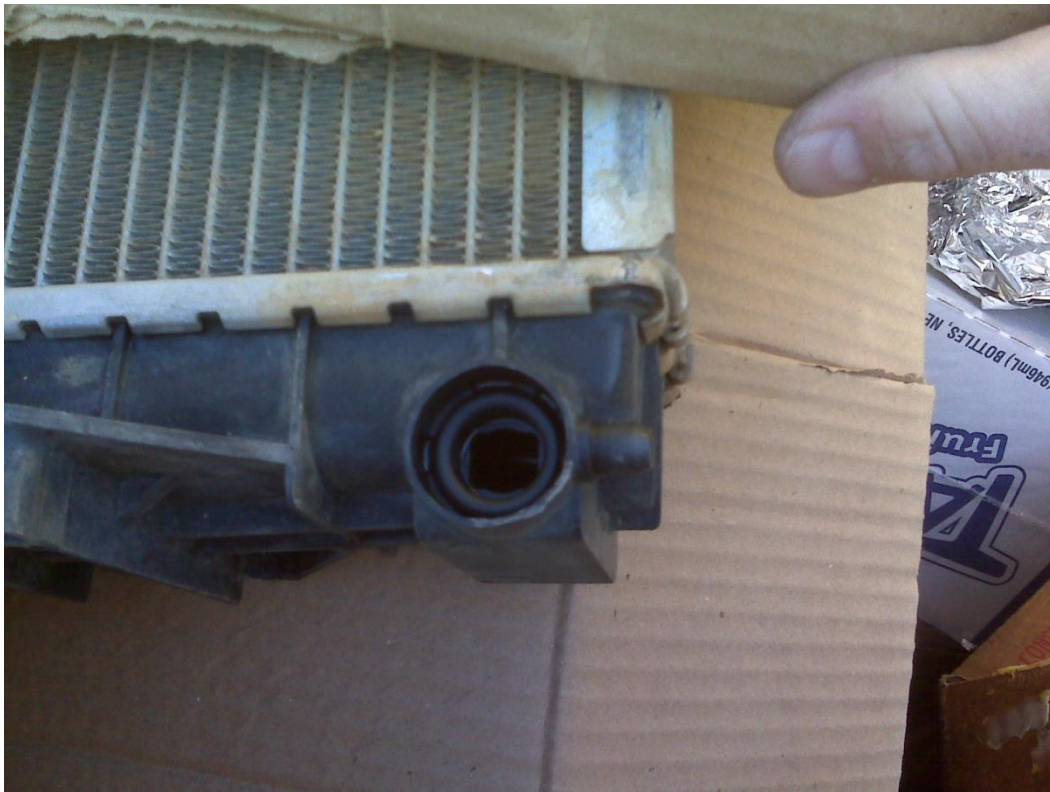
As I was draining the radiator for the heater line disconnect, the radiator experienced a catastrophic failure. I was standing by the truck and the trickle of antifreeze suddenly turned into a flow of antifreeze. I looked down and quickly realized I was running out of bucket space. My attempts to close the valve/draincock were futile as there were no threads to engage with the valve. None. Apparently the female threads on the radiator are pressed into the radiator cavity with an insert of some sort. My assumption is that when I opened the valve, this turning motion stripped the insert within the radiator. The result: a perfectly square hole with nothing for the valve to grab, thus, closing the hole.

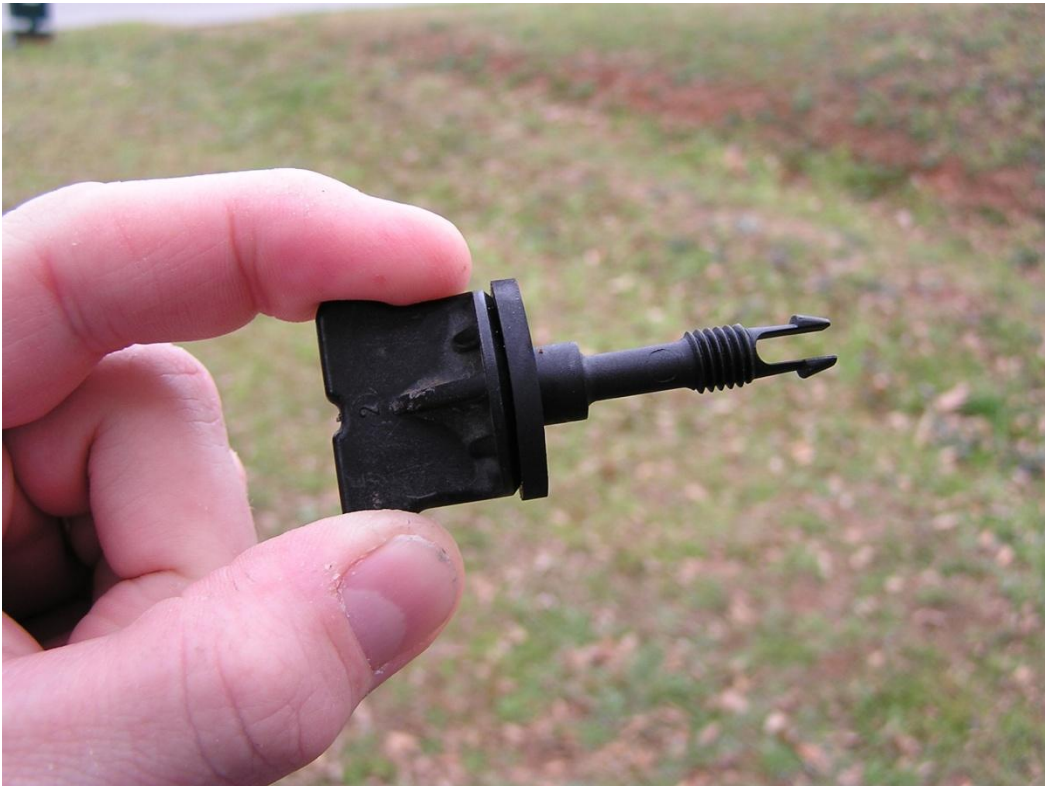
Fastener Engineering Rule #1 – the easily replaced part is always engineered to be LESS durable than the core part. Note the perfect draincock. Not a scratch on it, no evidence of being cross threaded, etc. Just one of those things... actually, it's just one of those almost \$700 things. Low and behold, the radiator part number has been superseded, and interestingly enough, the draincock has been redesigned. Who woulda thunk it? Come to find out, there are over 300 of the radiators on back-order and I was very fortunate that a dealer local to me had one in stock. I guess I was also very fortunate that this valve didn't let go on the road somewhere. Maybe there was a way a good radiator shop could fix it, but those places are nearly extinct now (like all the other good specialty shops), and I couldn't afford the downtime either.

Something else I'm not really impressed with is the fact that you just about have to disassemble the whole front end of truck to get the radiator out. By the way, the service manual is lying when it comes to radiator R&R. Don't believe it.
