Revised June 2015

Dealer Service Instructions for:

## **Safety Recall R25 / NHTSA 15V-313 Driver Airbag Inflator**

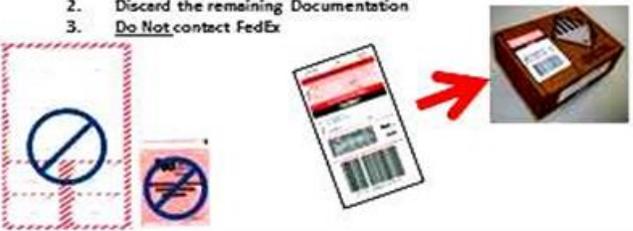
1. Peel off the backing of the FedEx Ground PRP Shipping label and affix to top of box to left of the Class 9 label.
- Use the scribe line on the box as a guide
- The FedEx Ground PRP Shipping label must not touch any portion of the printing to the right of the scribe line.

2. Discard the remaining Documentation
3. **Do Not** contact FedEx

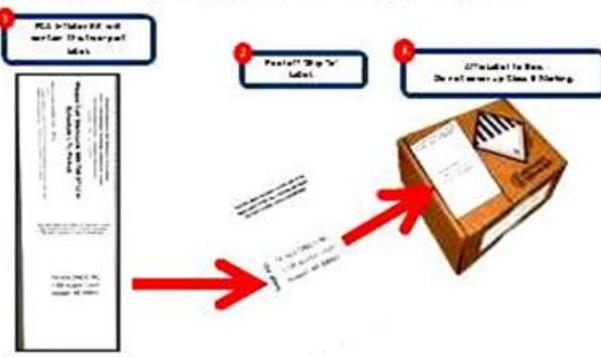
a) New Labels will begin shipping in each kit starting mid May, 2015

1. Peel off the backing of the FedEx Ground PRP Shipping label and affix to top of box to left of the Class 9 label.
2. Use the scribe line on the box as a guide
3. The FedEx Ground PRP Shipping label must not touch any portion of the printing to the right of the scribe line.

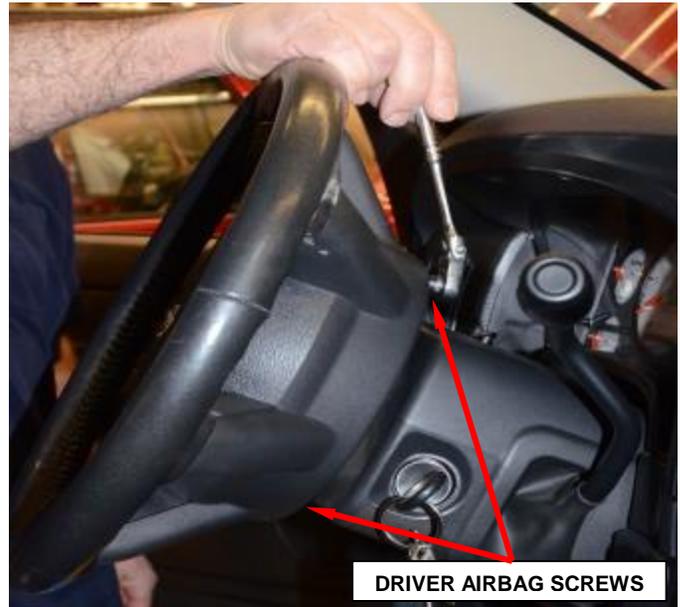
**Figure 1 - Driver Airbag Screw Location**

1. Use this procedure to replace the driver airbag inflator.
  - **For LX, L2 and LE model vehicles**, continue with **Section C. Replace Driver Airbag Inflator – LX, L2 and LE.**
  - **For all other models**, continue with **Step 2.**
2. Disconnect and isolate the negative battery cable. Wait two minutes for the system capacitor to discharge before further service.
3. Remove and save the two driver airbag screws that secure the driver airbag to the steering wheel armature from the underside of the steering wheel (Figure 1).

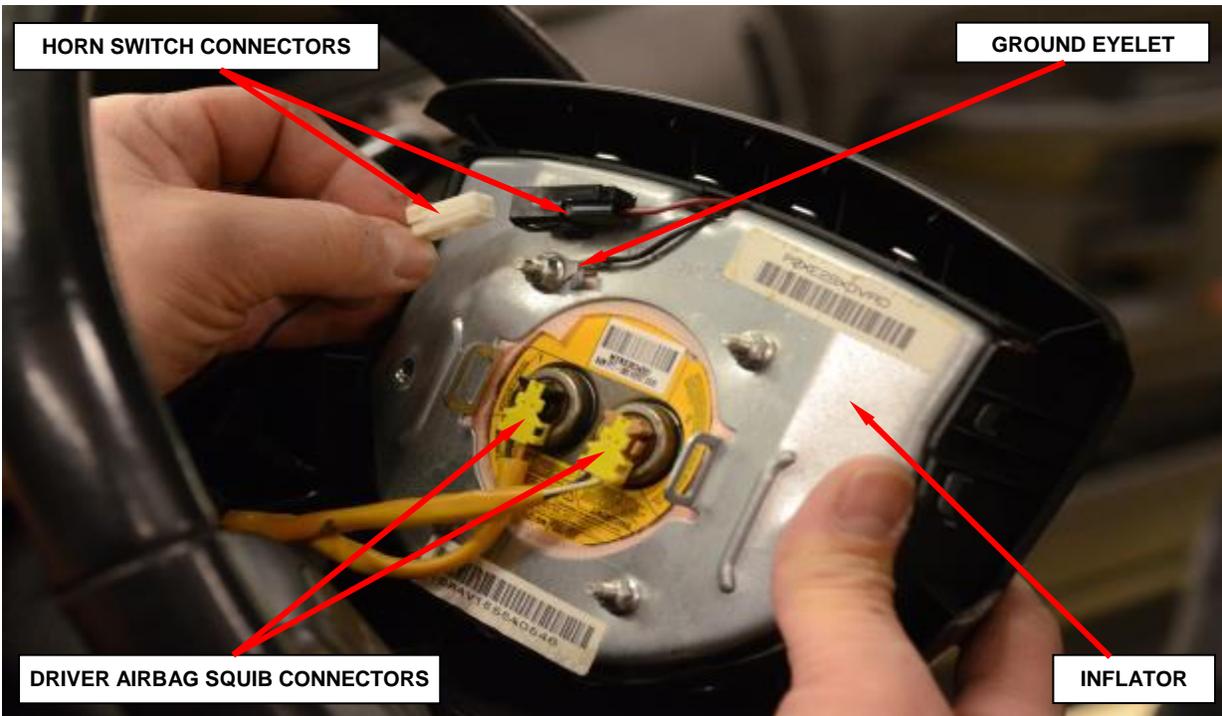
Figure 2 – Driver Airbag Electrical Connections

4. Pull the driver airbag away from the steering wheel far enough to access the three electrical connections on the back of the driver airbag housing (Figure 2).
5. Disconnect the horn switch connector, which is located on the back of the driver airbag housing (Figure 2).

25. Connect the steering wheel wire harness connector for the horn switch to the horn switch connector which is located on the back of the inflator assembly (Figure 2).

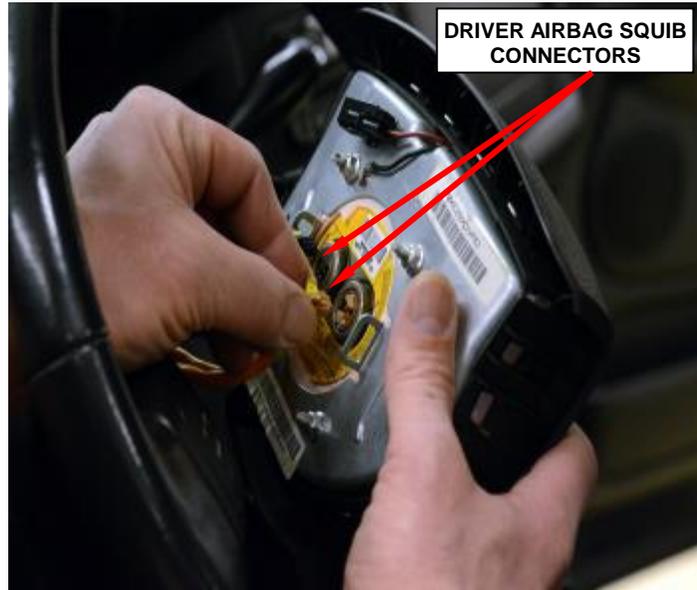
**Figure 3 – Driver Airbag Squib Connectors**

6. Disconnect the two driver airbag squib connectors. Depress the latches on each side of the connector insulator and pull the insulators straight out from the driver airbag inflator to disconnect them from the connector receptacles (Figure 3).

23. Position the driver airbag to the steering wheel to connect the three electrical connections on the back of the driver airbag housing (Figure 3).

24. Connect the two driver airbag squib connectors to the driver airbag inflator assembly connector receptacles by pressing straight in on the connector. Be certain to engage each keyed and color-coded connector to the matching connector receptacle (**See figure 14 and note on page 15**). Be certain that each connector is fully engaged in its receptacle by listening carefully for a distinct, audible click as the connector latches snap into place (Figure 3).

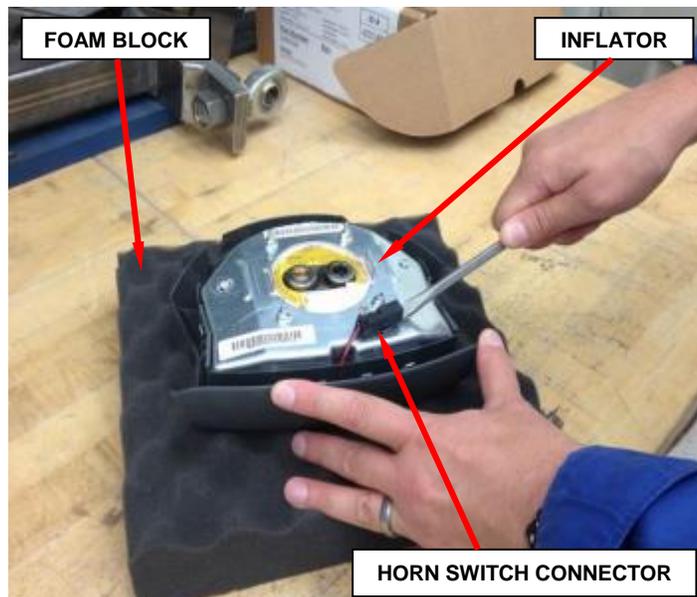
**Figure 4 – Horn Switch Connector**

7. Remove the driver airbag from the steering wheel.
8. Place the driver airbag on a soft surface to prevent damage using the foam block provided with the inflator kit (Figure 4).
9. Remove the horn switch connector from the inflator assembly using a flat head screwdriver (Figure 4).

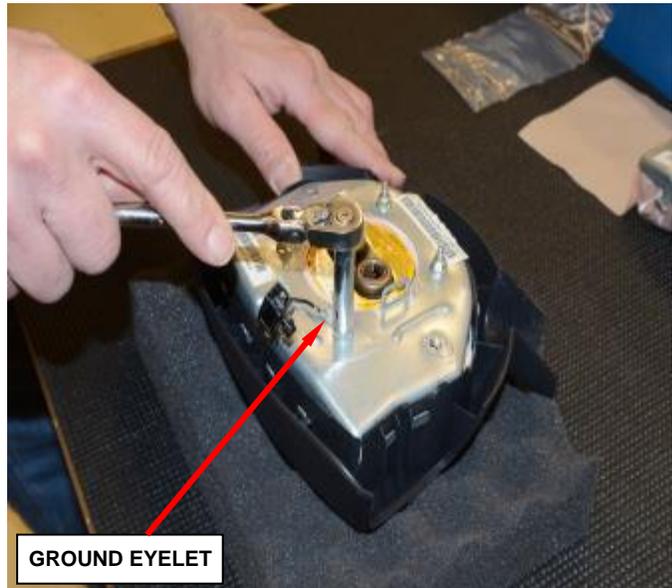
**Figure 5 – Ground Eyelet**

10. Remove and discard the nut holding the ground eyelet to the inflator assembly and remove the ground eyelet from the stud (Figure 5).

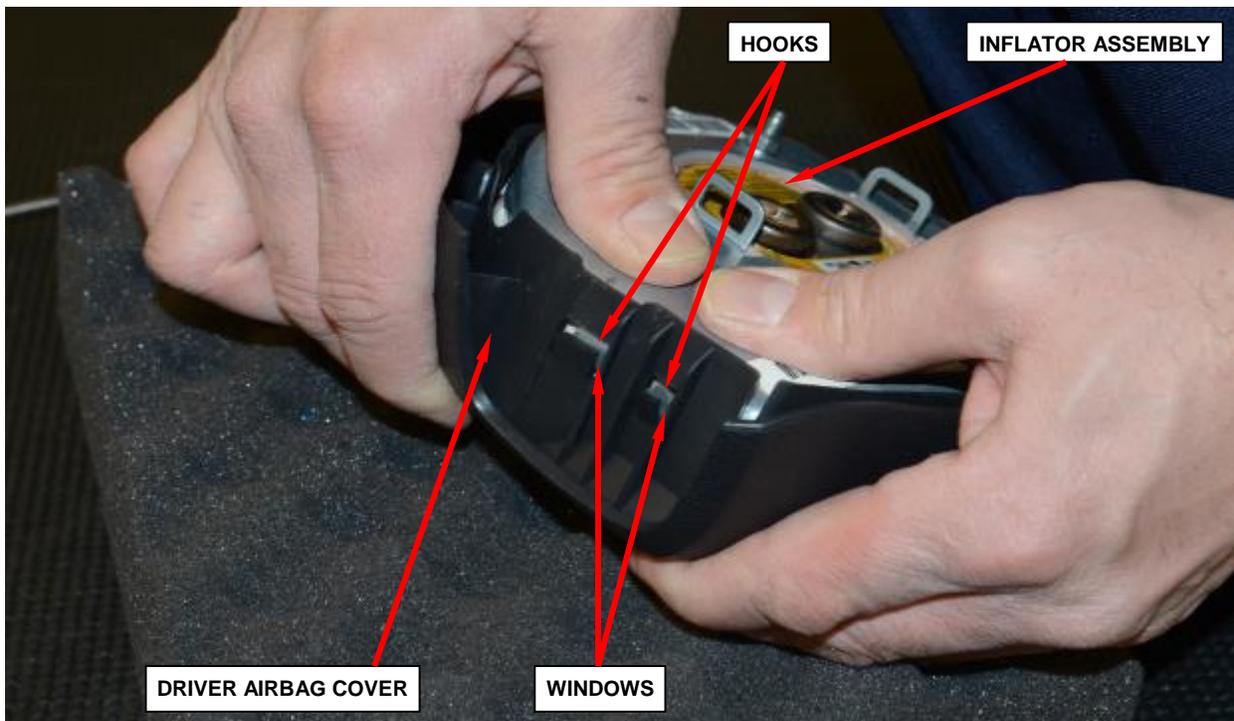
**Figure 6 – Left Side Driver Airbag Cover to Inflator Assembly Hooks**

11. Remove the driver airbag cover starting with the left side by pressing down on the inflator assembly until the hooks unsnap from the windows (Figure 6).

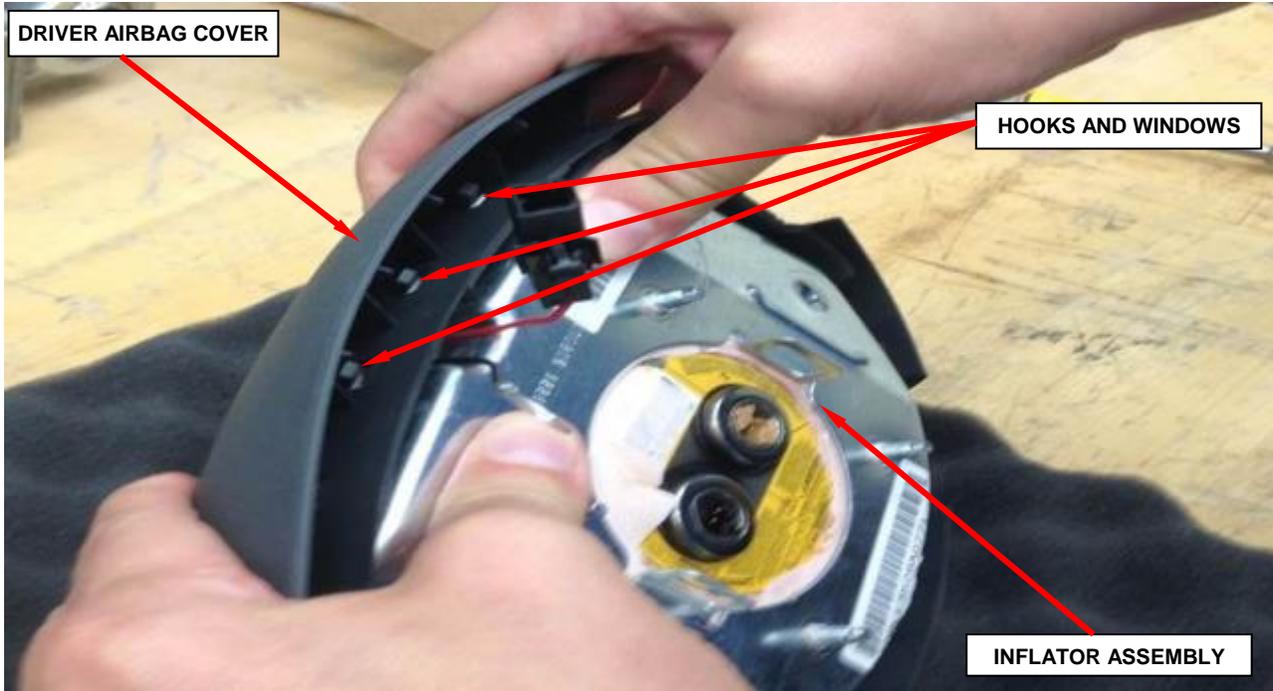
**Figure 7 - Top Driver Airbag Cover to Inflator Assembly Hooks**

12. Unsnap the top hooks by pressing down on the inflator assembly until the hooks unsnap from the airbag cover windows (Figure 7).
13. Unsnap the right side hooks by pressing down on the inflator until the hooks unsnap from the driver airbag cover.
14. Gently pull the inflator assembly up slowly making sure that the hooks are clear from the windows on all sides (Figure 8).

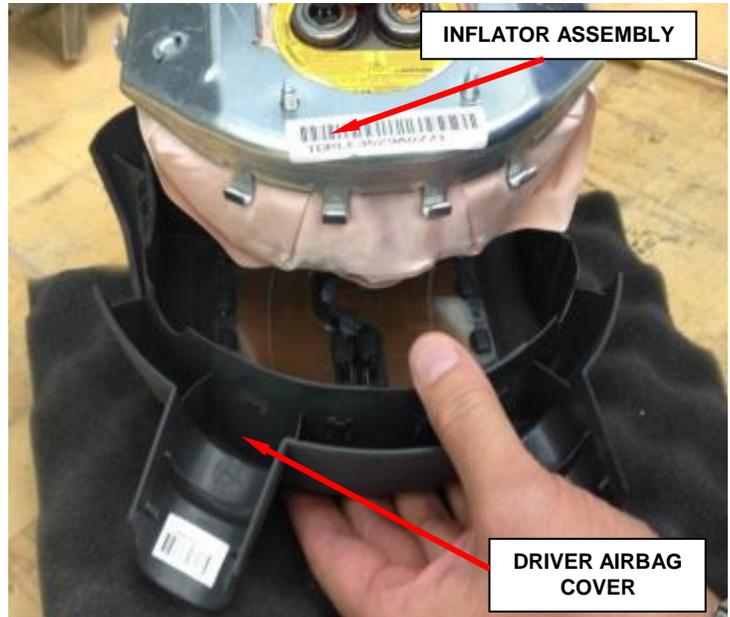
Figure 9 - Inflator Assembly to Driver Airbag Cover

- 15. Disengage the inflator assembly from the driver airbag cover and set aside for shipping (Figure 9).

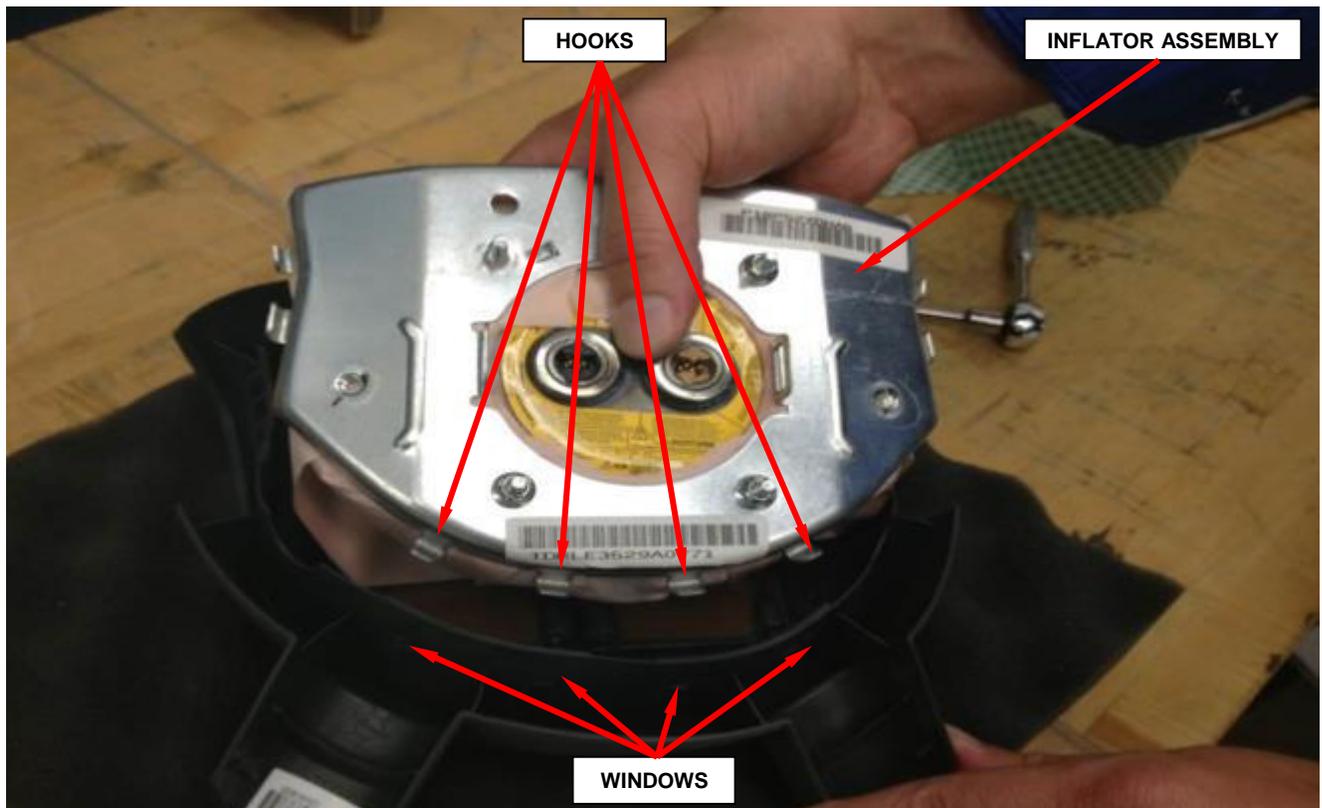
Figure 10 - Inflator Assembly to Driver Airbag Cover Hooks

- 16. Install the new inflator assembly to the original driver airbag cover by first inserting the bottom hooks into the windows (Figure 10).

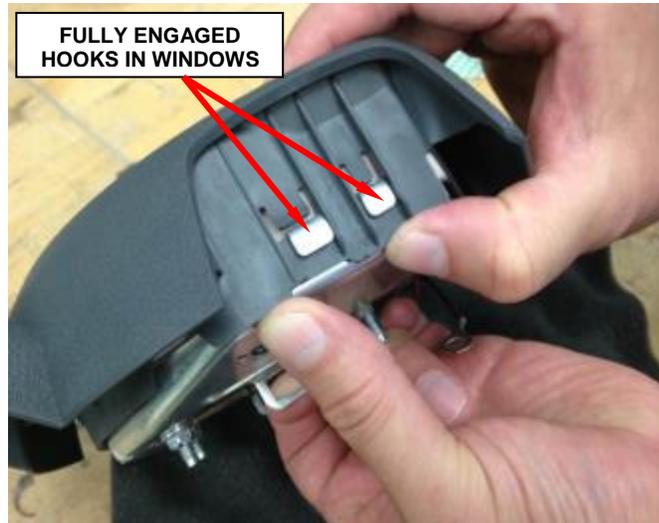
**Figure 11 – Inflator Assembly Hooks**

17. Snap the remaining hooks on all sides into place.
18. Pull on the inflator assembly to fully engage the windows and hooks on all sides (Figure 11).

**NOTE: Visually inspect and verify that all the hooks are fully engaged with the windows on all sides.**

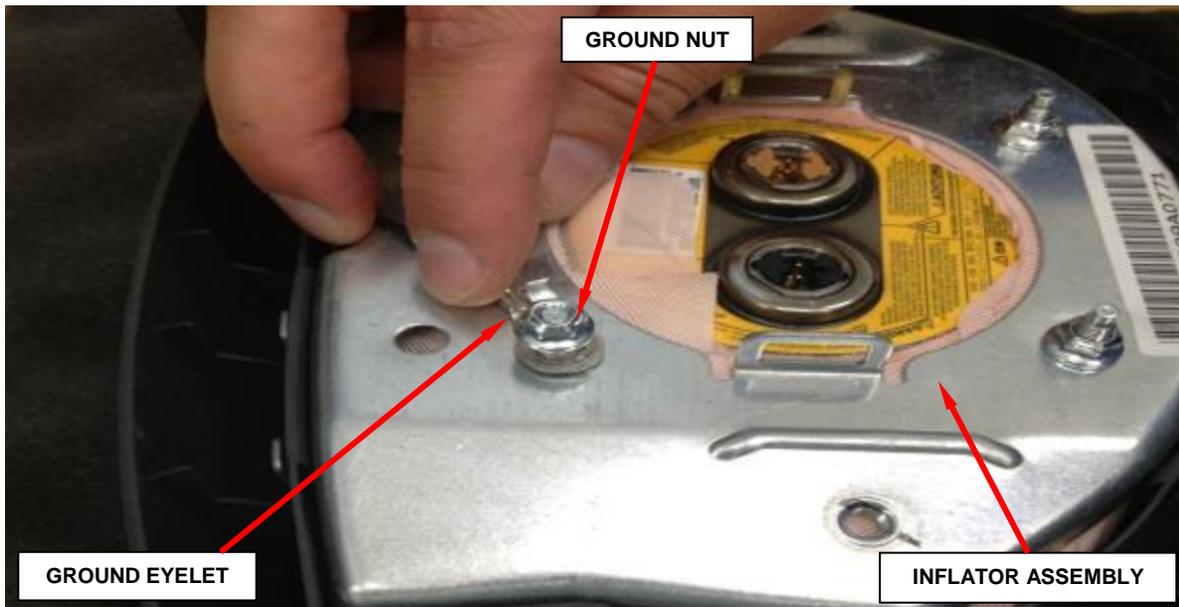
**Figure 12 – Ground Eyelet to Inflator Assembly**

19. Install the ground eyelet on the upper left stud (Figure 12).
20. Install the new ground nut and tighten to 26 in. lbs. (3 N·m).

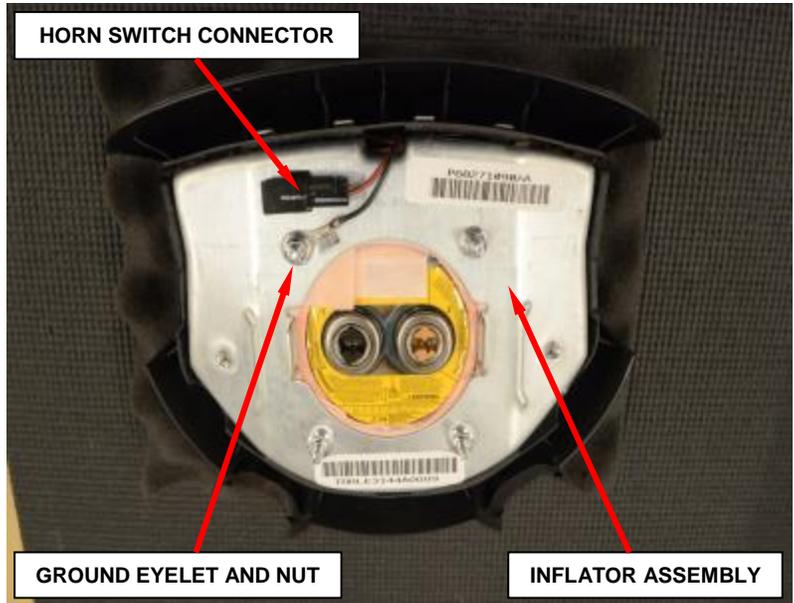
**Figure 13 – Driver Airbag Assembly**

21. Clip the horn switch connector to the inflator assembly (Figure 13).

22. Driver airbag retrofit is complete (Figure 13).

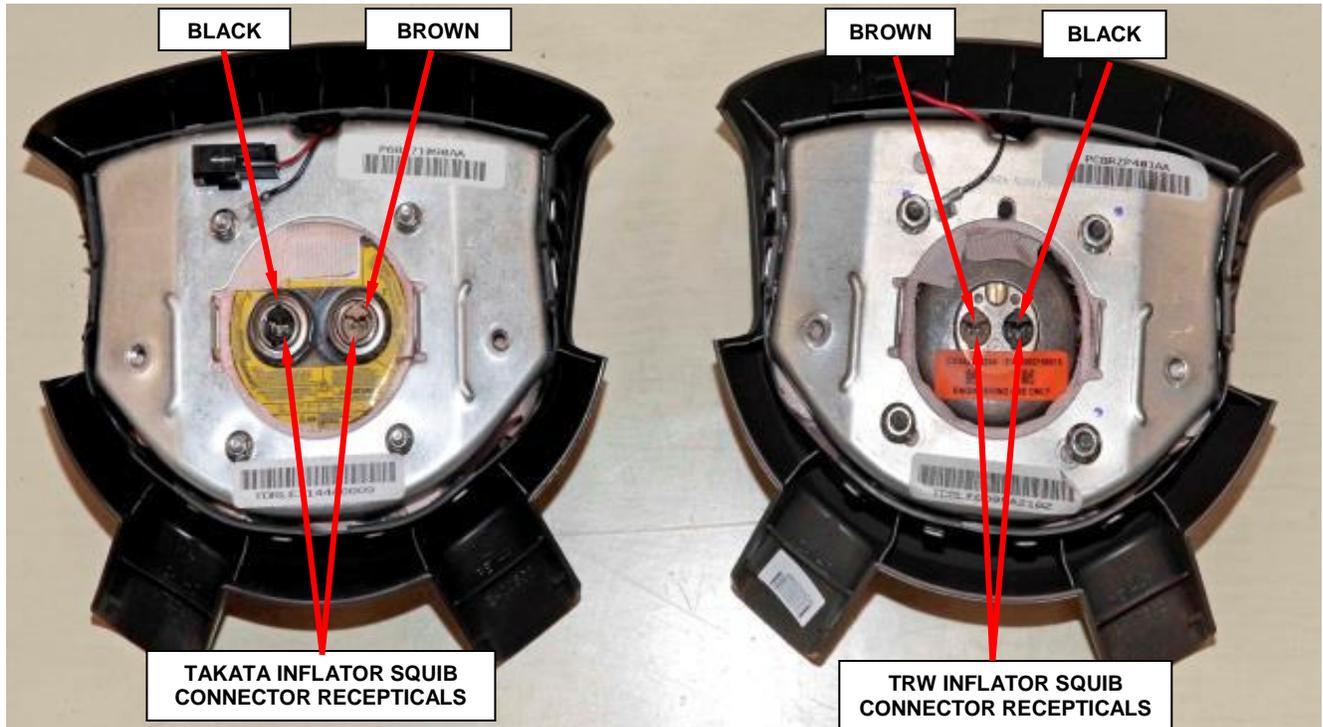
Figure 14 – Squib Connector Receptacles

**NOTE:** The squib connector receptacle locations on the driver airbag inflators are switched between the original Takata inflator and the TRW replacement inflator kits. Squib connectors are keyed and color coded for error proofing (Figure 14).

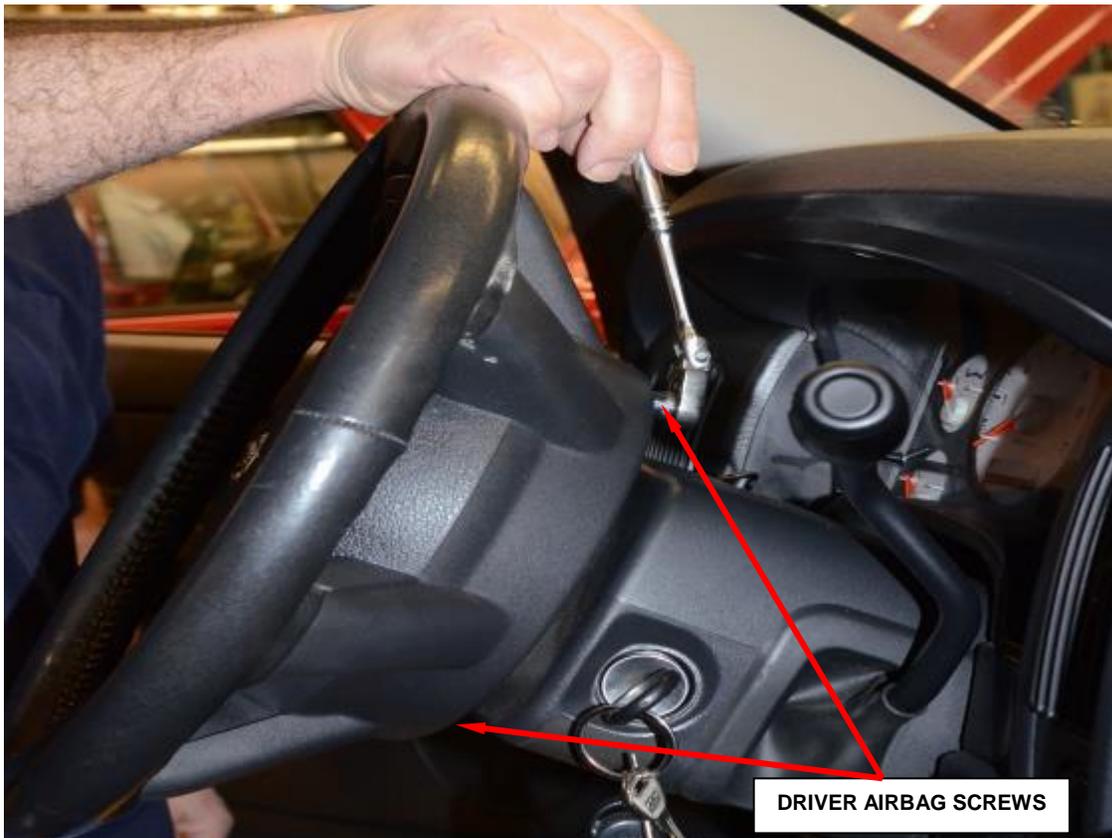
**Figure 15 – Typical Driver Airbag Screw Locations**

1. Use this procedure to replace the driver airbag inflator.
2. Disconnect and isolate the negative battery cable. Wait two minutes for the system capacitor to discharge before further service.
3. Remove and save the two screws that secure the driver airbag assembly to the steering wheel armature from the underside of the steering wheel (Figure 15).

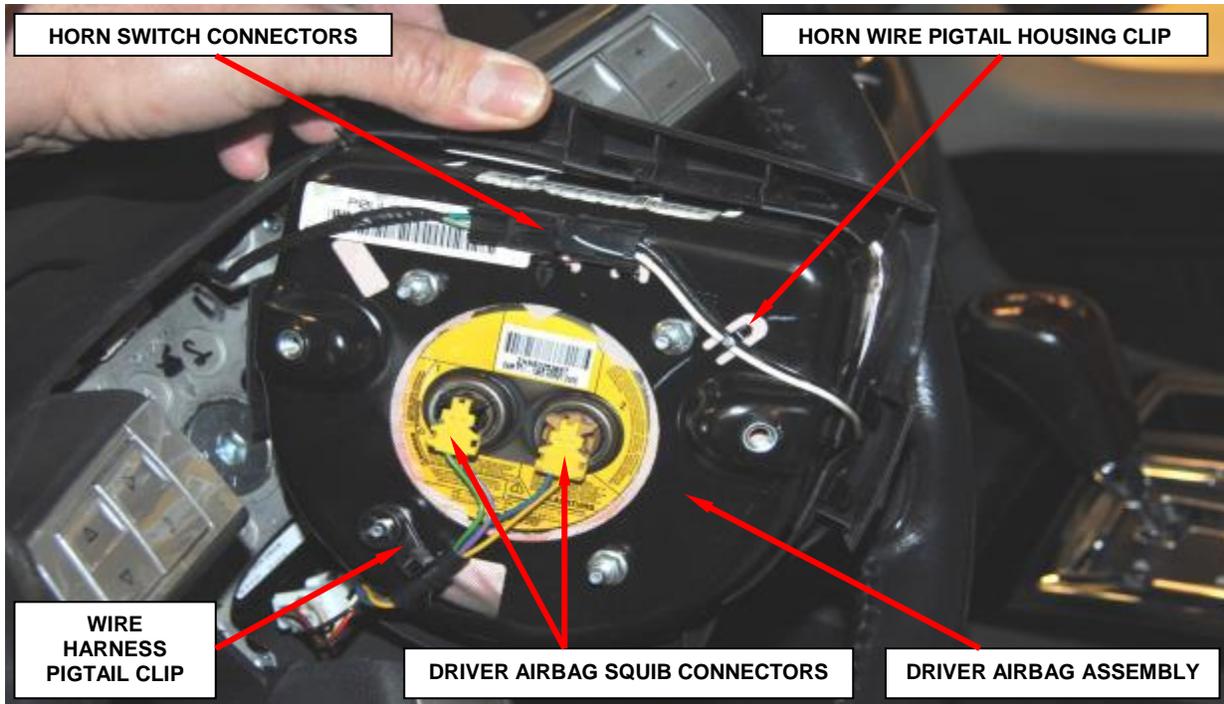
**Figure 16 – Electrical Connectors**

4. Pull the driver airbag assembly away from the steering wheel far enough to access the three electrical connections on the back of the airbag housing (Figure 16).
5. Disconnect the steering wheel wire harness connector for the horn switch from the horn switch feed pigtail wire connector, which is located on the back of the driver airbag housing (Figure 16).

23. Position the driver airbag to the steering wheel to connect the three electrical connections on the back of the airbag housing.
24. Connect the two driver airbag squib connectors to the airbag inflator connector receptacles by pressing straight in on the connector. Be certain to engage each keyed and color-coded connector to the matching connector receptacle. Be certain that each connector is fully engaged in its receptacle by listening carefully for a distinct, audible click as the connector latches snap into place (Figure 16).

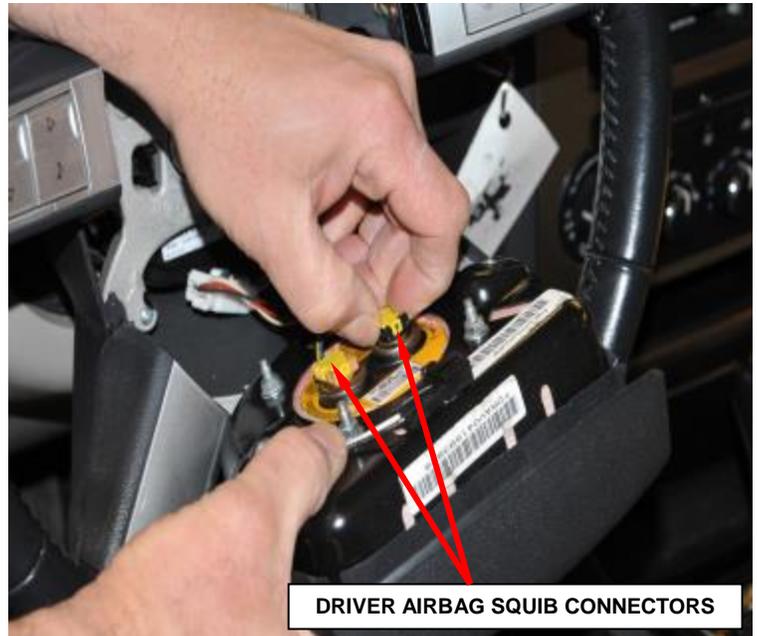
**Figure 17 – Airbag Squib Connectors**

6. Disconnect the driver airbag squib connectors. Depress the latches on each side of the connector insulator and pull the insulators straight out from the airbag inflator to disconnect them from the connector receptacles (Figure 17).
7. Disengage the wire harness pigtail clip from the housing (Figure 18).
8. Remove the driver airbag assembly from the steering wheel.

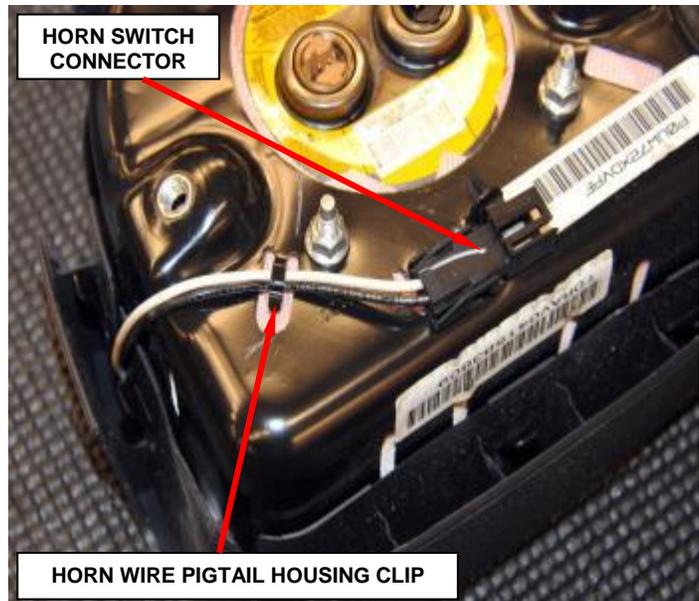
**Figure 19 – Horn Connector**

9. Place the driver airbag on a soft surface to prevent damage using the foam block provided with the inflator kit.
10. Remove the horn switch connector from the housing (Figure 19).
11. Remove the horn wire pigtail from the housing clip (Figure 19).
12. Remove the driver airbag cover starting with the left side by pressing down on the driver airbag housing until the hooks unsnap from the windows (Figure 20).

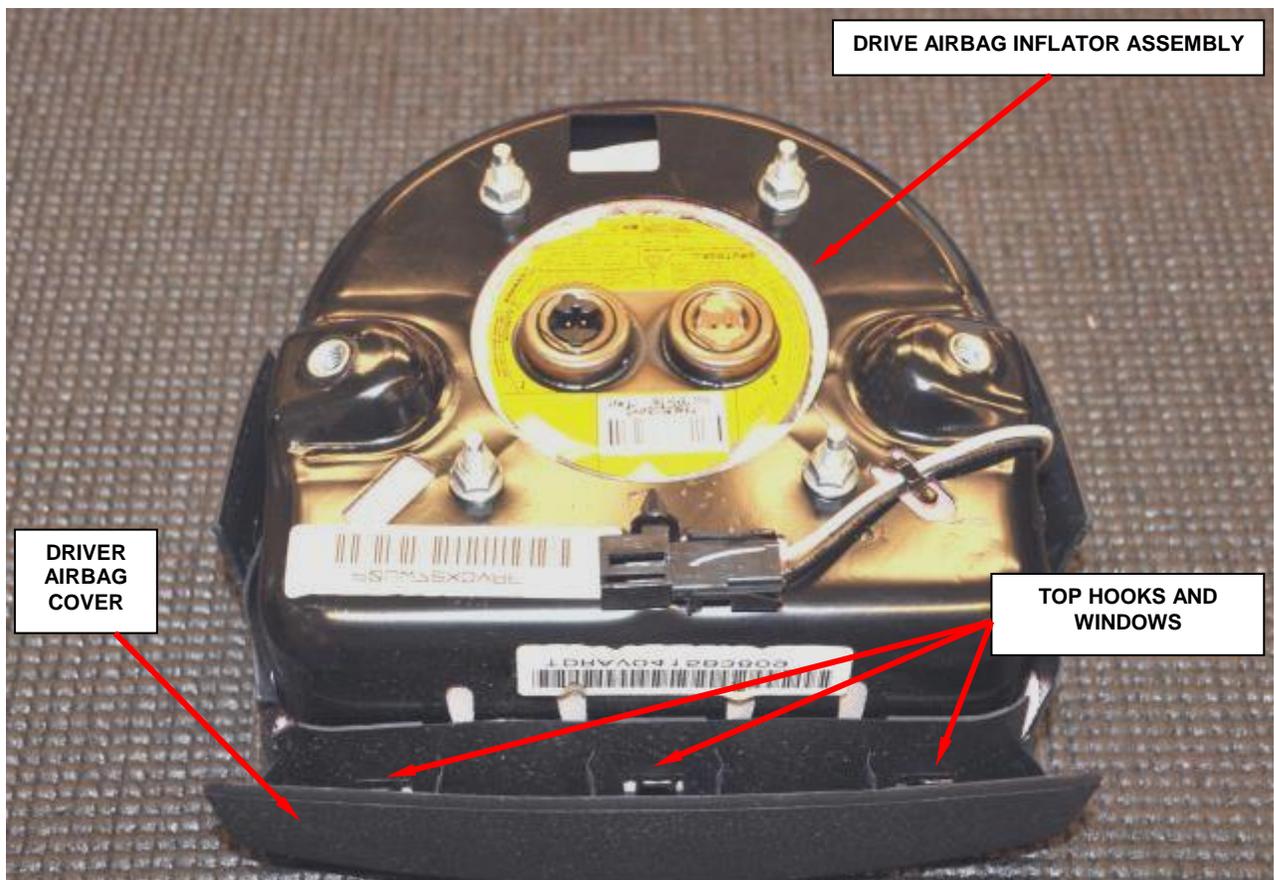
Figure 21 – Driver Airbag Inflator Assembly to Cover

13. Unsnap the bottom hooks by pressing down on the housing until the hooks unsnap from the cover.
14. Unsnap the right side hooks by pressing down on the housing until the hooks unsnap from the cover.
15. Gently pull the housing up slowly making sure that the hooks are clear from the windows on all sides.
16. Disengage the old inflator assembly from the driver airbag cover and set aside for shipping.
17. Install the new inflator assembly to the original driver airbag cover by first inserting the top hooks into the windows (Figure 21).

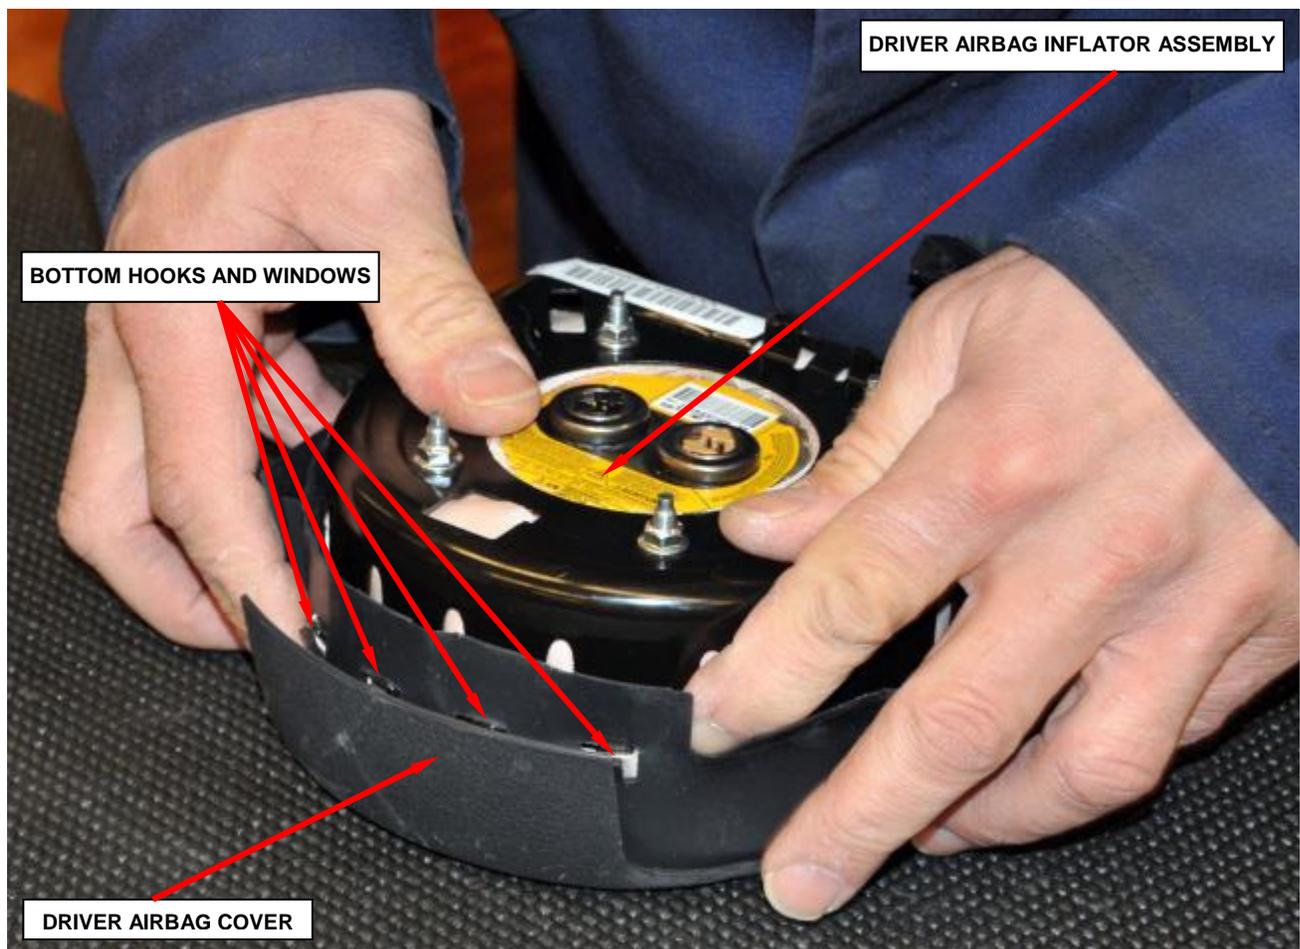
**Figure 22 - Verify Hook and Window Engagement**

18. Snap the remaining hooks in the windows on all sides into place.
19. Pull on the driver airbag inflator assembly to fully engage the hooks and windows on all sides of the driver airbag cover (Figure 22).

**NOTE: Visually inspect and verify that all the hooks are fully engaged with the windows on all sides.**

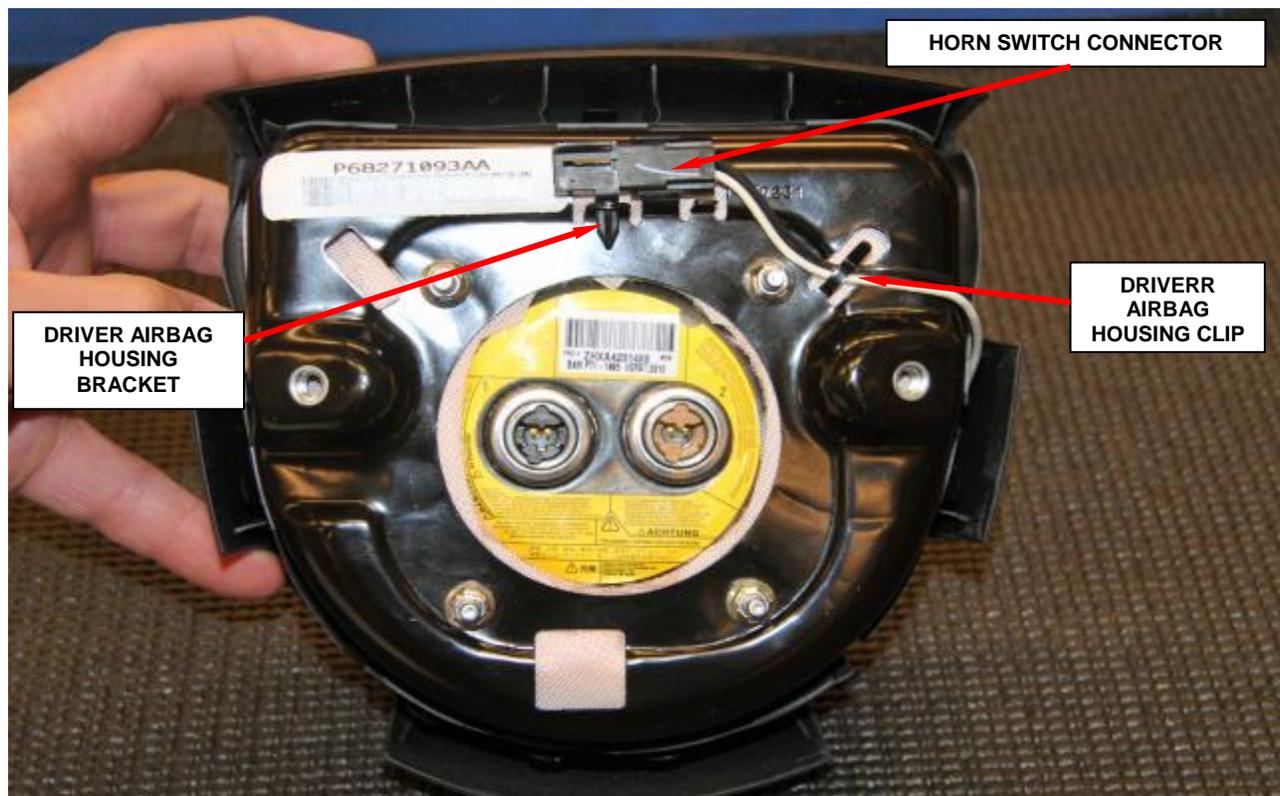
Figure 23 – Horn Switch Connector

20. Clip the horn switch connector to the driver airbag housing bracket (Figure 23).
21. Engage the horn switch wire harness pigtail to the driver airbag housing clip (Figure 23).
22. Driver airbag retrofit is complete (Figure 23).

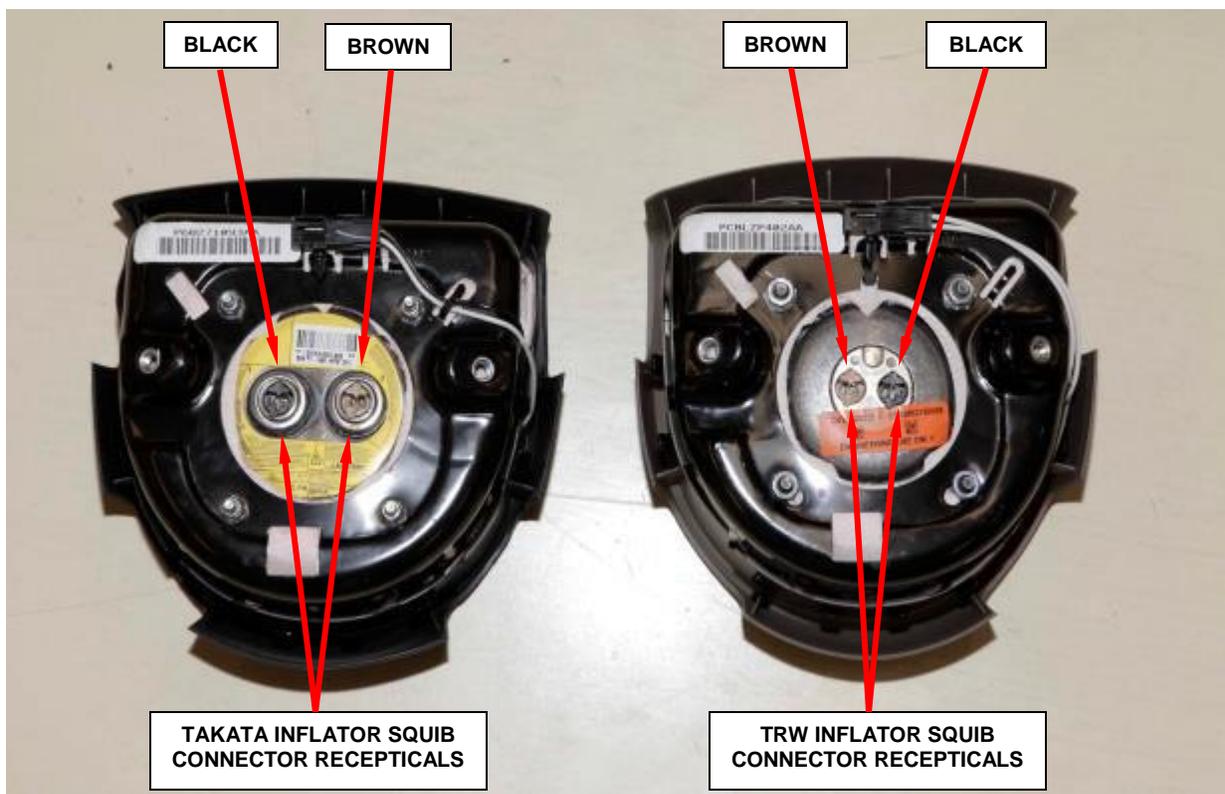
**Figure 24 - Squib Connector Receptacles**

**NOTE: The squib connector receptacle locations on the driver airbag inflators are switched between the original Takata inflator and the TRW replacement inflator kits. Squib connectors are keyed and color coded for error proofing (Figure 24).**
